Troubleshooting Guide

imageRUNNER ADVANCE

C5560 Series

April, 2017
OIP Field Quality Assurance Div.

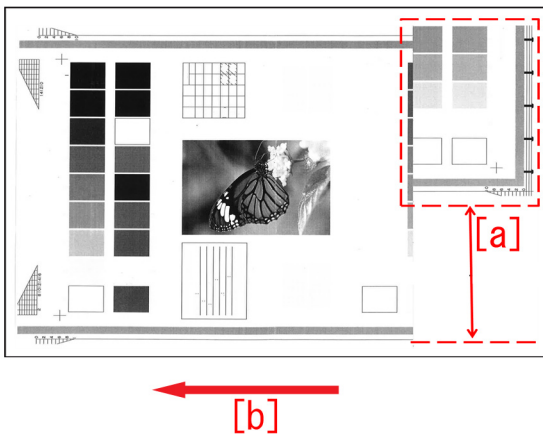
Image displacement when using ADF due to broken grounding sheet

When reading single-sided pages from ADF consecutively, image displacement [a] may occur on output images. "[b] indicates the feed direction."

- 1) Prepare a new stream read glass (FL3-4769-000) and replace the old one.
- 2) Output the image having shown the symptom, and check that the symptom does not occur. If the symptom does not improve, then check other factors.

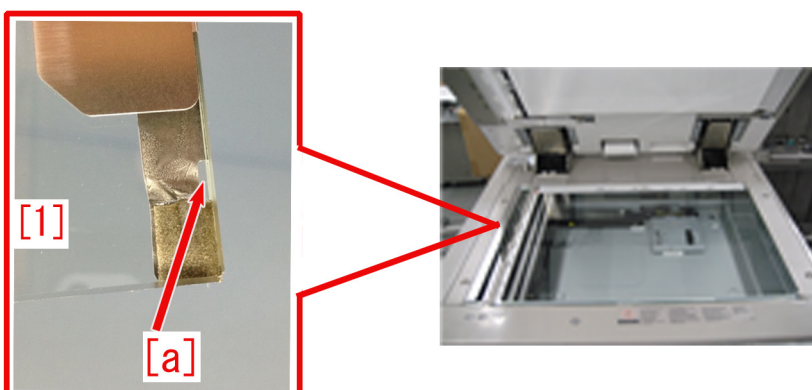
The machine malfunction and it result in the above symptom when not properly grounded because the grounding sheet [a] located in the stream read glass unit [1] of the reader unit is broken or torn.

[Service part] FL3-4769-000 Stream read glass

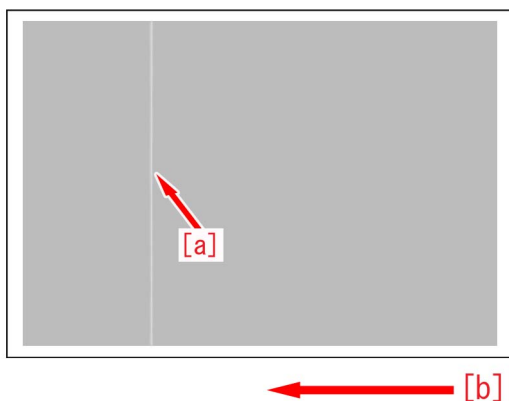
Horizontal white line appears at 120mm from the leading edge of the sheet with a Bk halftone image

When a halftone image is printed out in Bk mode with the setting of Heavy 1 (106-128g/m²), a horizontal white line [a] may appear at 120mm from the leading edge of the sheet.

The above mentioned symptom occurs when a sheet of paper rushes into the secondary transfer roller, its impact is propagated through the ITB to the drum and the speed of the drum fluctuated.

Due to the difference in the primary transfer engagement/disengagement operation, setting up Bk mode Heavy1 (106-128g/m²) exposes the symptom.

Print out after setting Paper Settings to Heavy2 (129-150gmm²).

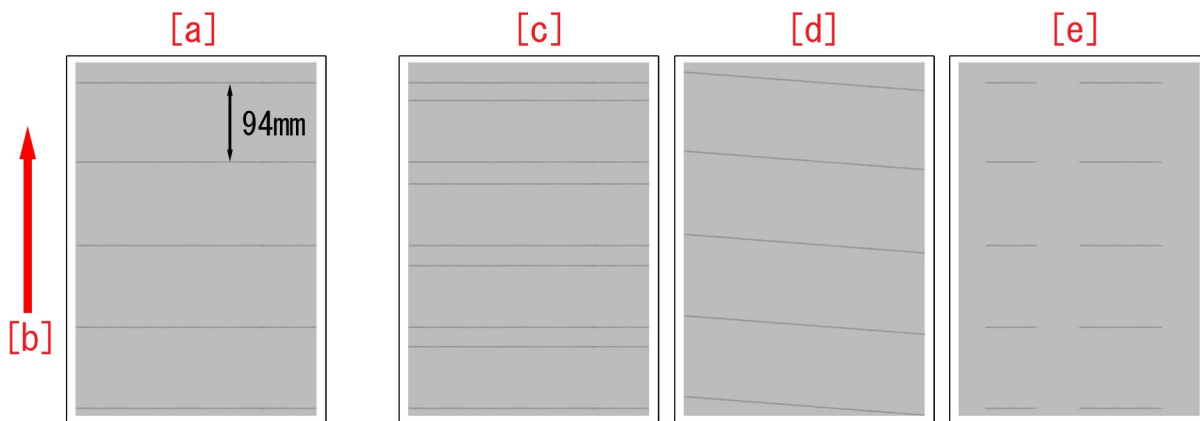
Horizontal lines with 94mm pitch [a] may occur when a halftone image is output.

[Reference] In this symptom, the horizontal lines may occur as bunches of plural lines [c] / diagonal lines [d] / lines with dropped part [e].

The inside of main body infinitesimally vibrates when the main body is operating.

The friction force of surface of the drum becomes uneven due to the vibration which the drum gets.

Therefore the several thousand paper feeding may make the difference of shaved surface condition of the drum.

Since there are different shaved conditions on the surface of the drum, uneven potential is generated at the each point and then cause the foregoing symptom.

1) Select Settings/Registration > Adjustment/Maintenance > Maintenance > Clean Inside Main unit, and press "Start" button.

2) Output the image having shown the symptom, and check that the symptom does not occur.

If the improvement of the symptom is not sufficient, a couple of implementations of Procedure 1) are required.

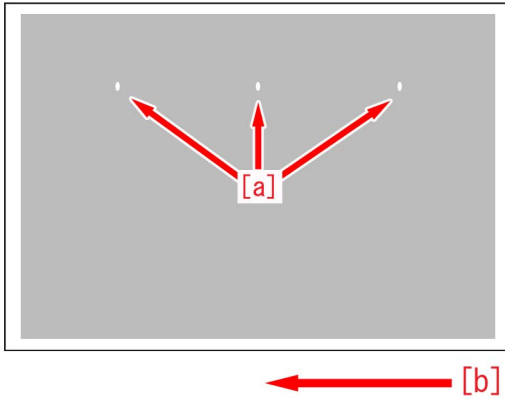
Repeating image failure [a] whose intervals are same pitch may occur.
 The arrow [b] indicates the direction of feeding.

The image failure occurs when rollers have foreign matters or flaws.

Check the rollers or Belts of a) to j) below.

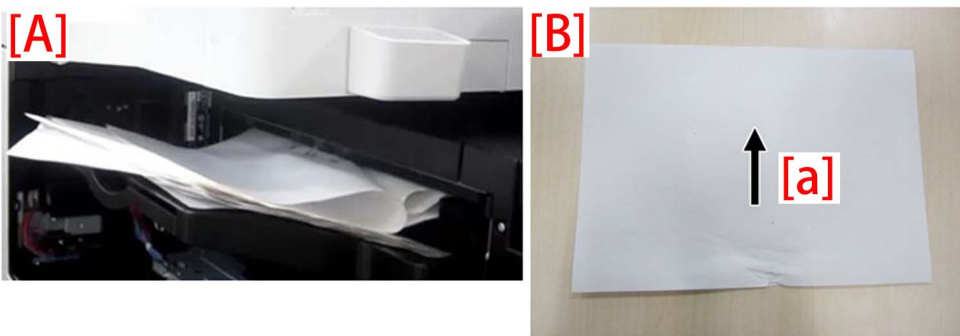
When taking copy with single sheet output using inner finisher, this may lead to a poor stacking [A] or wrinkles/tear [B] at the center of the trailing edge of paper due to unfinished delivery of paper to the tray.

A poor adjustment of the aligning plate of the processing tray unit encumbers a proper delivery of paper and this ends in the aforementioned symptom.

When the above mentioned symptom has occurred, adjust the width of the aligning plate following the procedure below.

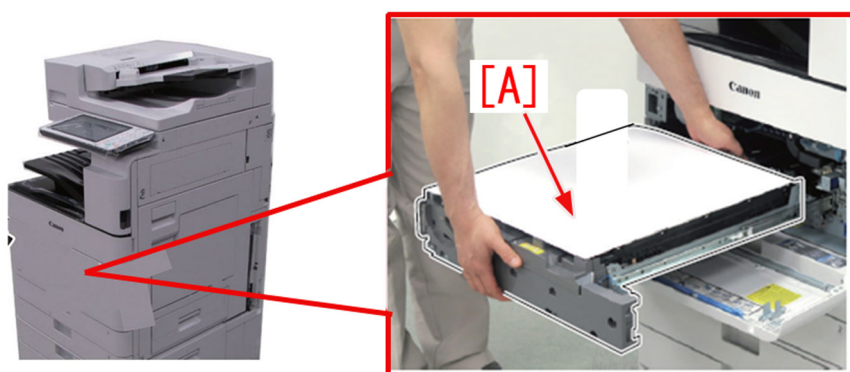
Waste toner may leak when pulling out the process unit [A] from the main body.

- 1) Check the shutter unit and if the shutter spring has come off, prepare and attach a new spring [FU2-1194-000].
- 2) Check the operation of the shutter, and install the process unit to the main body.
- 3) When removing and installing the process unit in the future, be sure not to touch the spring in the shutter as it tends to come off easily.

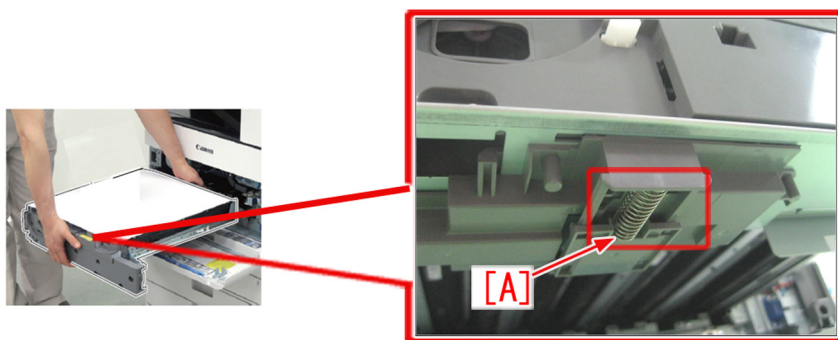
When removing the process unit from the main body, the shutter spring [A] located at the back of the process unit may come off if touched. The process unit is installed to the main body with no spring and is pulled out, the shutter does not close and it results in the above symptom.

[Service part] FU2-1194-000 SPRING TENSION

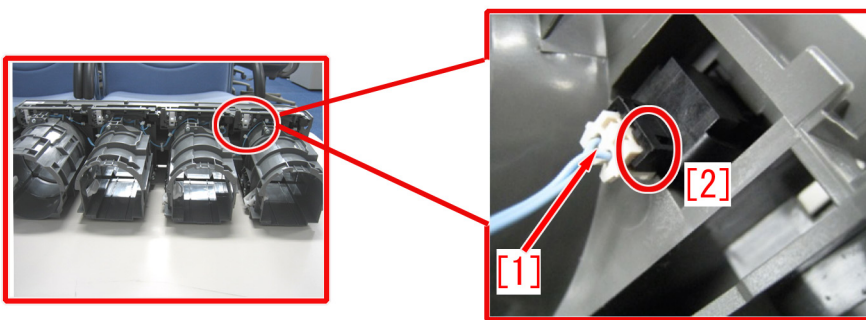
The connector [1] on the inner side of the toner bottle inner door interferes with the mold of the bottle front inner guide [2], and the connector cannot be fully inserted and the above-mentioned symptom may occur.

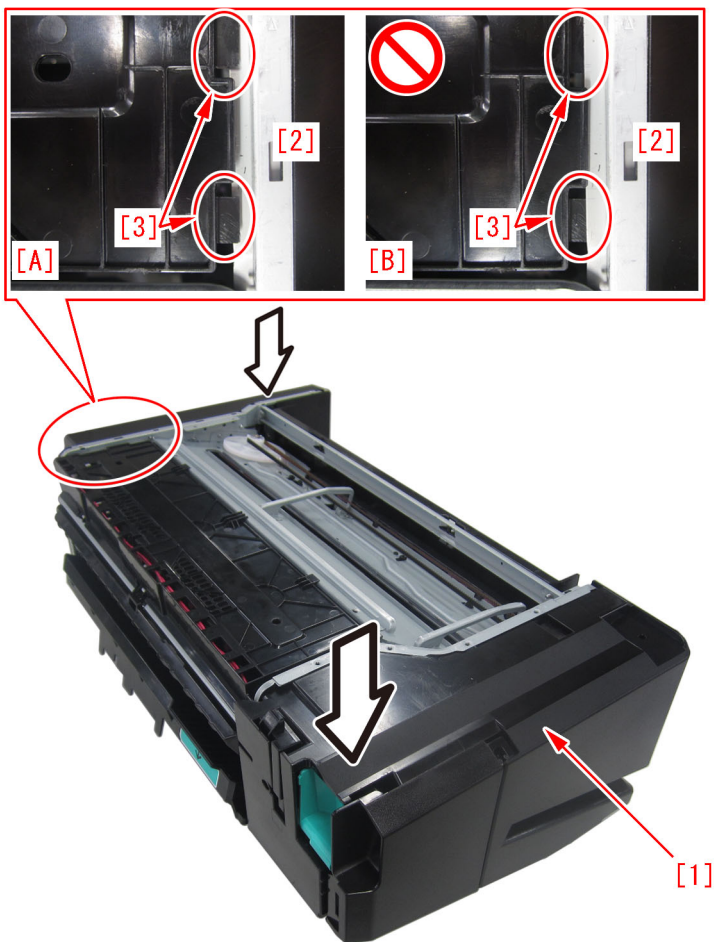
When installing the rail unit to the inner finisher [1], the frame of the finisher would be twisted if a downward force is applied to the area shown with the arrow while the finisher is faced upside down.

When a gap is created between the front end plate and the back end plate due to twist on the frame, the craw [3] of the molded part [2] may come off.

Fig. [A] is the normal state and Fig.[B] is where the craw of the molded part [2] came off.

When the craw of the molded part is off, install the rail unit after placing the craw of the molded part back in the correct place by firmly pressing the area shown with the arrow.

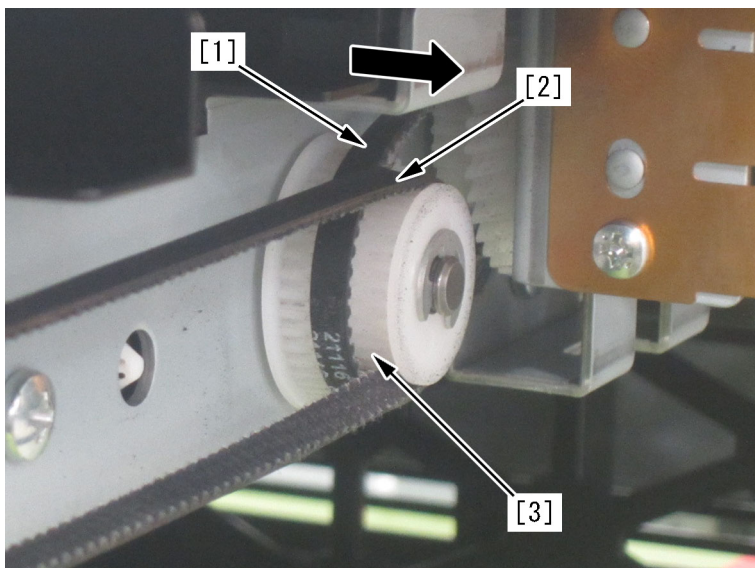
If the timing belt [1] on the rear side shifts in the arrow direction, it comes in contact with the timing belt [2] on the front side, and the timing belt on the front side is disengaged from the 30T/40T pulley [3], resulting in the above-mentioned symptom.

If the above-mentioned symptom occurs, remove the buffer pass unit and check whether the timing belt at the back of the machine is disengaged.

If the timing belt is disengaged, prepare a flange (FE8-8792-000) and a new E ring (XD9-0136-000).

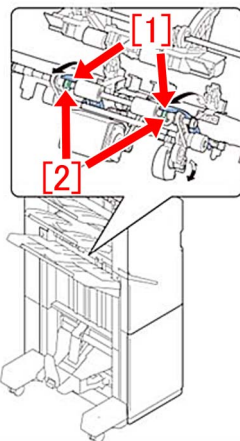
- 1) Operation failure of the front/rear tray auxiliary guide due to shift in engagement of the rack and the pinion [2] of the front/rear tray auxiliary guide [1]

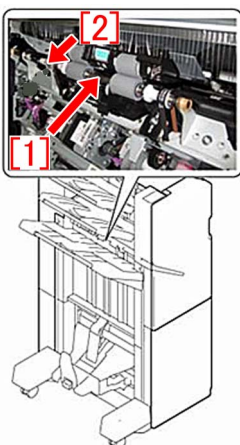
- 2) Operation failure of the front/rear tray auxiliary guide due to large clearance of the mount of the lower delivery roller [1] dislocating the bushing [2] on the rear side.
