Troubleshooting Guide

imageRUNNER ADVANCE

8500/6500 Series

April, 2018
OIP Field Quality Assurance Div.

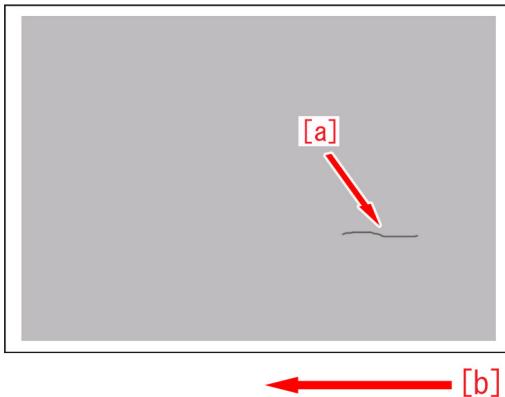
Black line in sub scanning direction [a] may occur.
The arrow [b] indicates the direction of feeding.

- 1) Remove the process unit by following the steps in Service Manual "Parts Replacement and Cleaning > Image Formation System > Cleaning the Process Unit".
- 2) Remove the developing unit by following the steps in Service Manual "Parts Replacement and Cleaning > Image Formation System > Removing the Developing Assembly".
- 3) Check to see if any fluffy foreign matter is attached to the developing sleeve [a] in the developing assembly and remove if found.

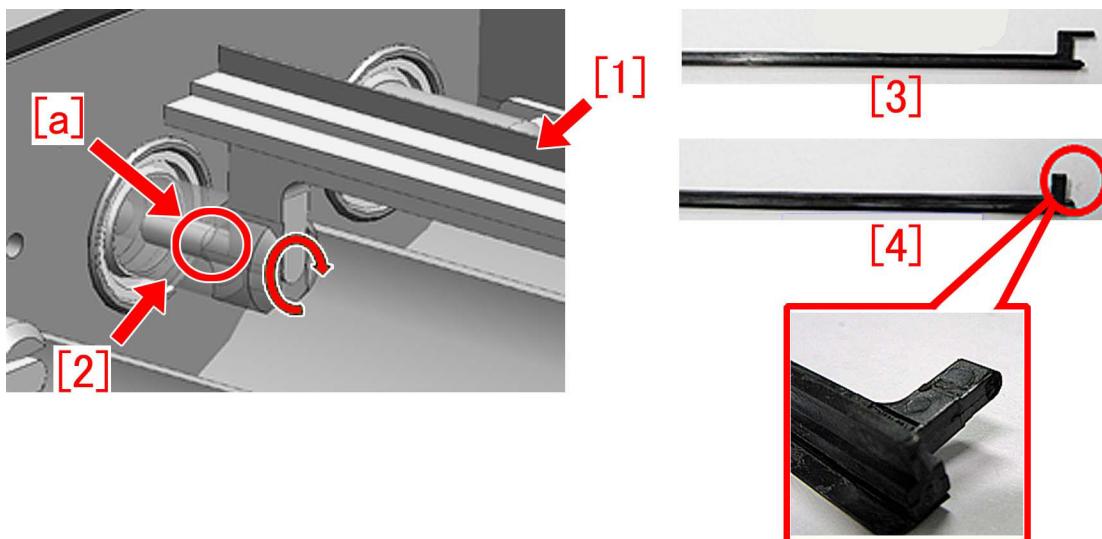
Figures below shows the configuration around the 20T gear and the second stirring rod, normal stirring rod [3] and the broken stirring rod [4].

3) If necessary, prepare and replace with a new type of either a stirring rod (FL3-2163-010) or a developing assembly (FM3-7384-020).

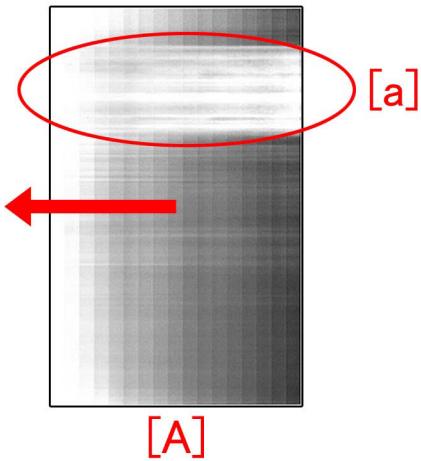
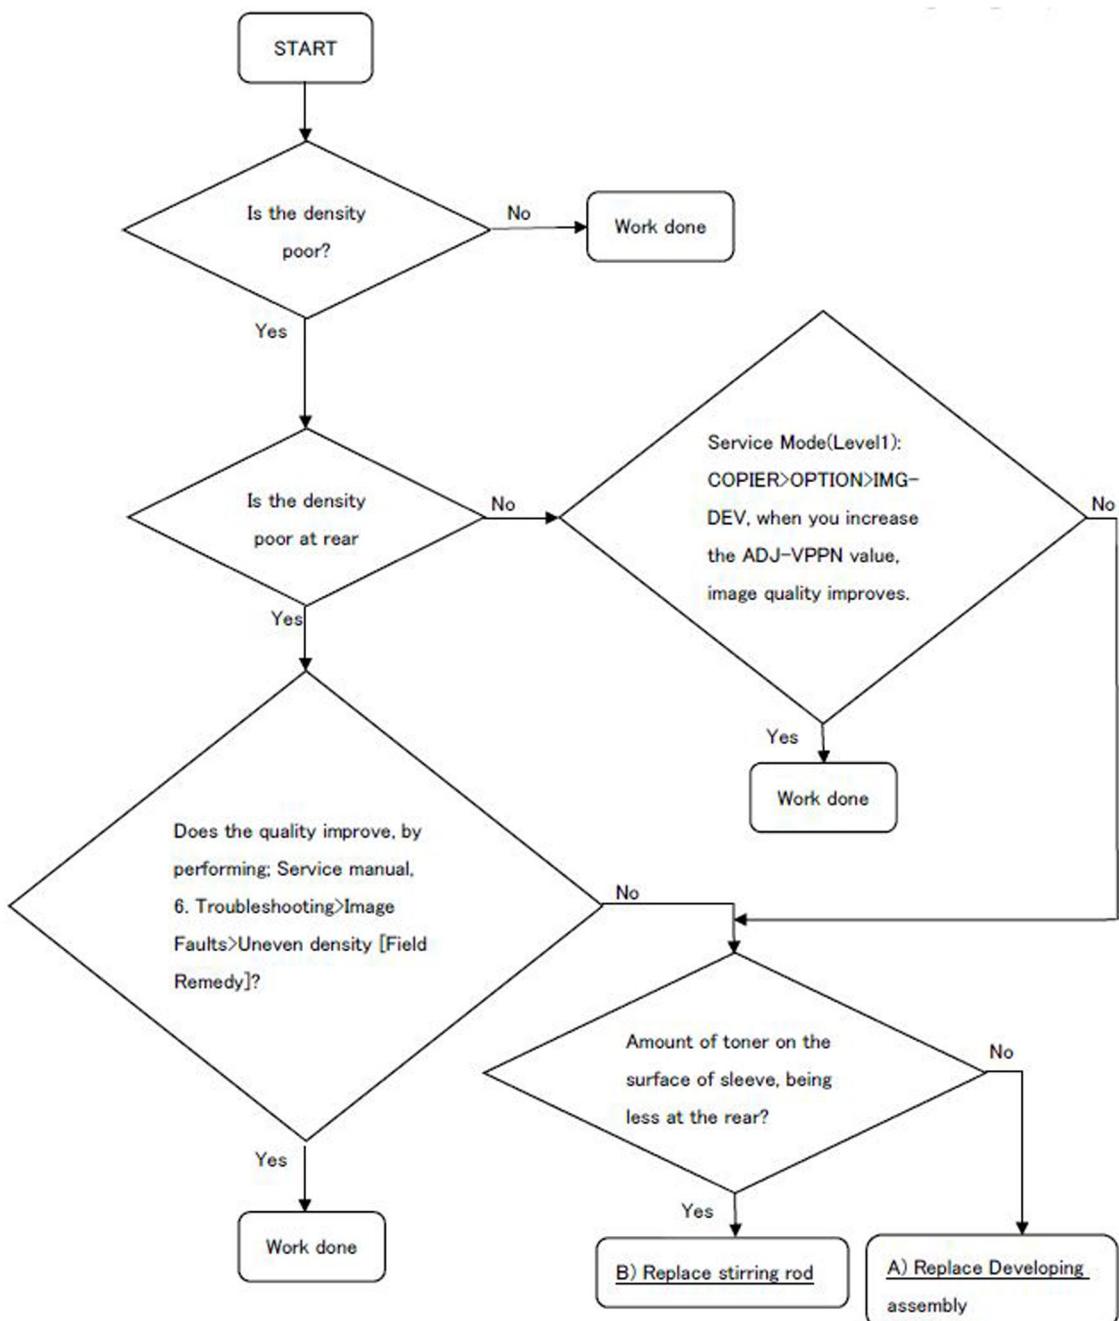
Figure [A] is a sample of test print with a white band [a] formed in the rear side. Arrow shows the paper feeding direction.

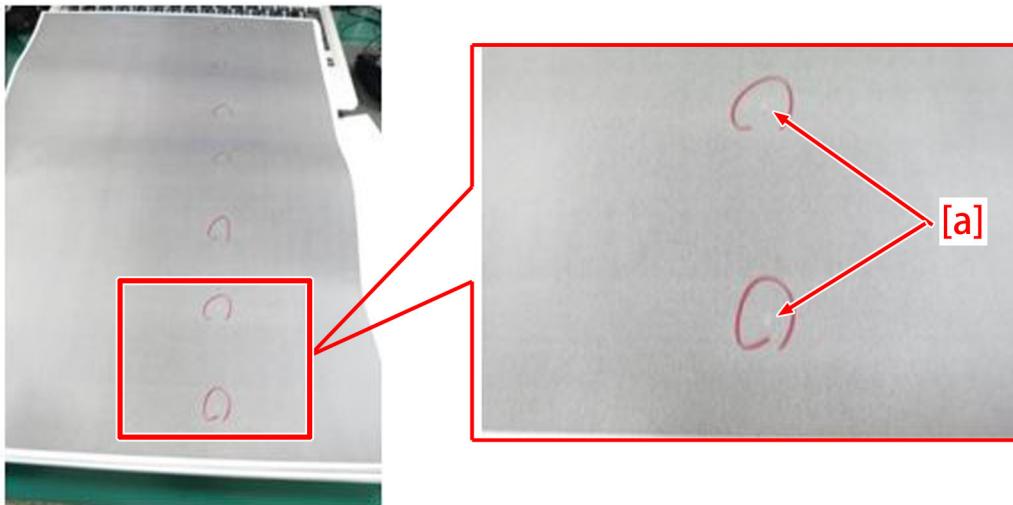
Stain (at regular intervals of 63mm) [a] may appear on image when printing.

Prepare and replace with a new developing assembly (FM4-5429-010).

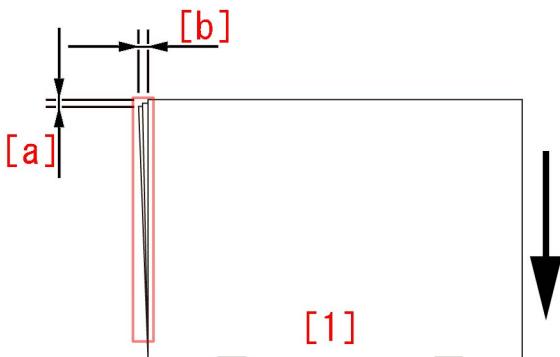
When using the booklet mode with a small number of sheets in the machine earlier than the following countermeasure cut-in serial numbers in factory, the folding position ([a] and [b]) of the output products [1] may be displaced and inconsistent as shown in the Figure below. The arrow indicates the feeding direction.

If the above-mentioned-symptom occurs, prepare the new-type roller guide [1] (FL1-5052-000), the new E ring (XD2-1100-325) and the saddle stopper assembly [2] (FM1-R635-000) which was newly set up as a service part to replace by following the procedure below. This procedure starts with the step after the booklet finisher is separated from the copier.

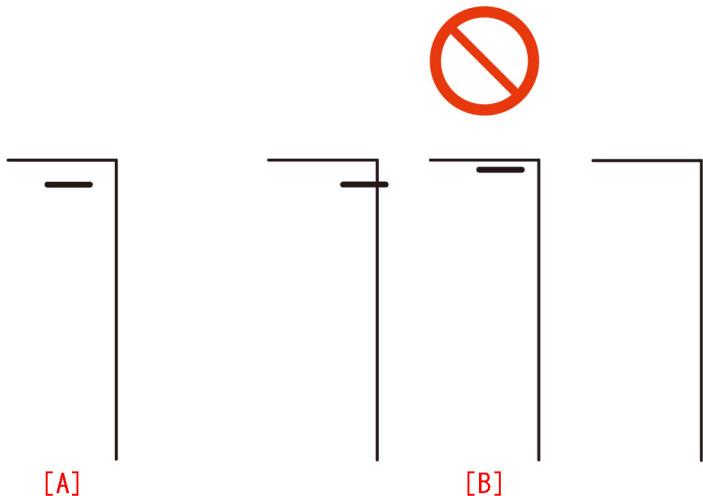
When using the manual stapler, staple position may be shifted and sheets may not be stapled due to a spring coming off. Fig.[A] shows correct stapling. Fig.[B] shows incorrect staple positions and missing staples.

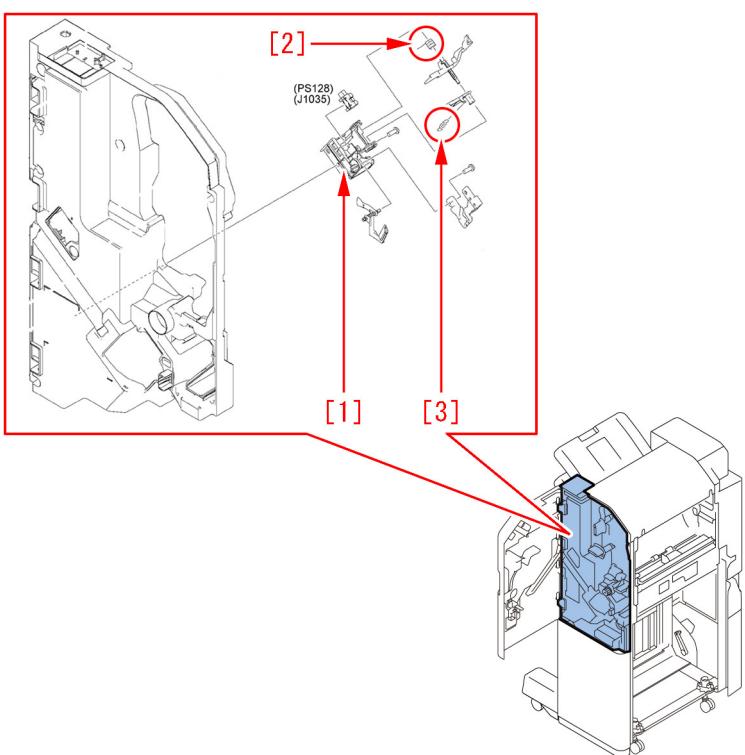
The torsion spring [2] or the tension spring [3] of the sensor holder [1] in the inner cover assembly comes off. It results in misdetection by sensor flags causing the above symptom.

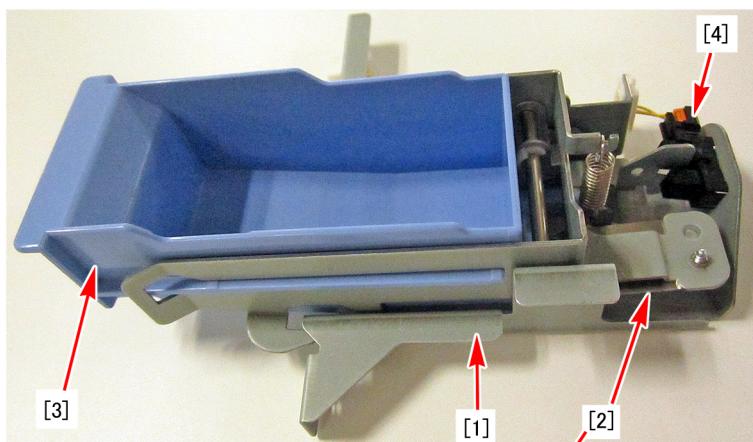
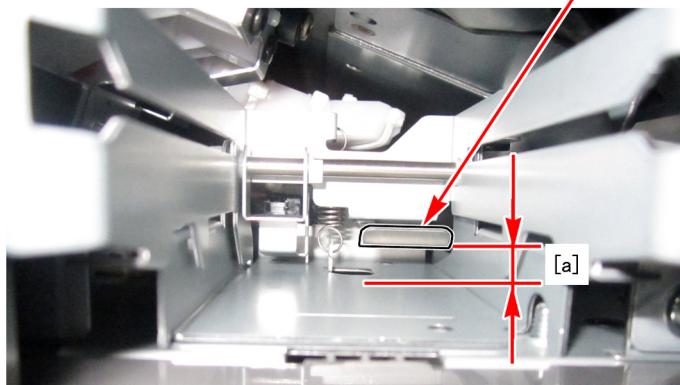
Due to the high position [a] of the leaf spring [2] of the staple collect unit [1], the waste staple case [3] is loosely fixed, the waste staple case is displaced, and the needle chip full sensor [4] detects falsely, which causes the above-mentioned symptom.

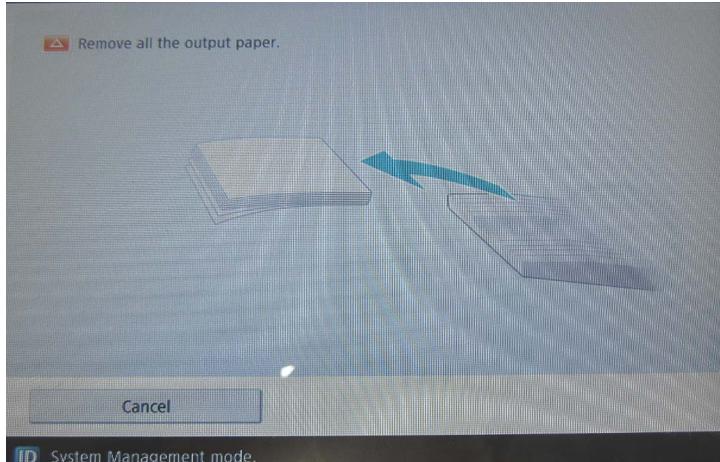
When delivering to the escape tray in printing or copying, "Remove all the output paper (Remove the paper in the delivery tray)" message may be displayed.

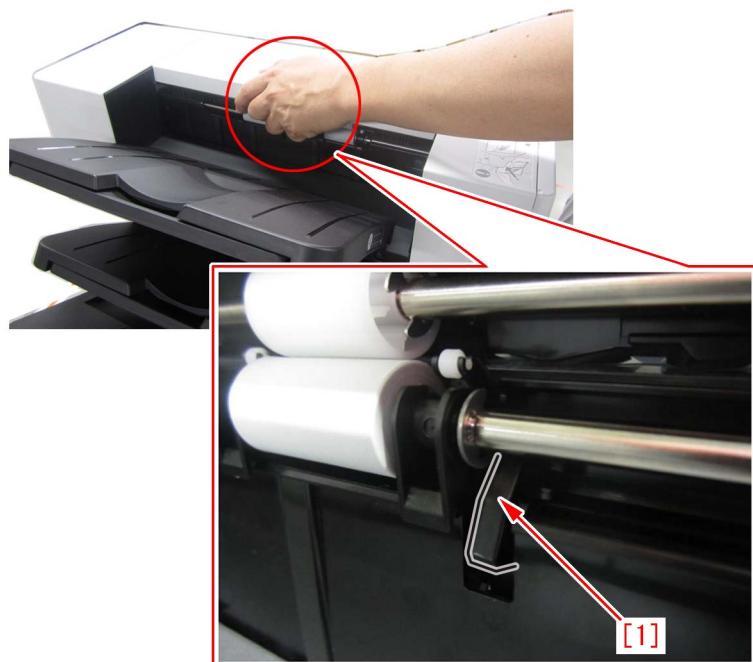
To install or move the finisher, if the worker holds the position shown in the below photo, the full detection sensor flag [1] is pressed towards the back side with fingers, then it becomes unable to come back to the normal position and ends in the above mentioned symptom.

The figure [A] shows a condition where the sensor flag is at a normal position and the figure [B], the sensor flag is pushed towards the back side.

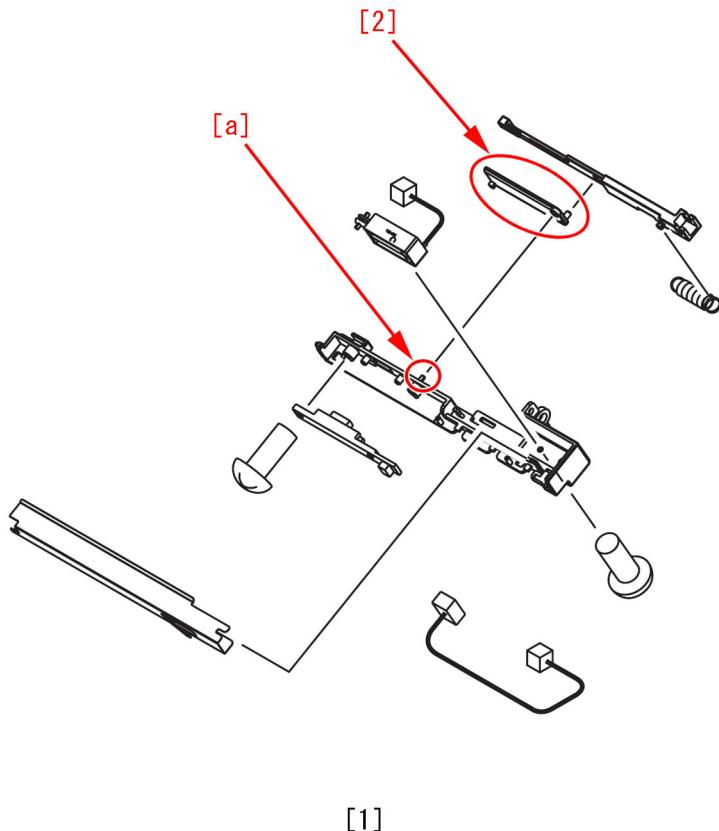
In the machines prior to the Countermeasure cut-in serial number in factory described below when opening the shutter [2] in the patch sensor assembly [1], the boss [a] which acts as a supporting point may break.

Stress caused by opening and closing the shutter applies to the root of the boss intensively for a long time, resulting in the above symptom.

When the above symptom occurs, refer to Service Manual and replace with the new type patch sensor assembly (FM3-7298-010) and the shutter (FC8-9669-010).

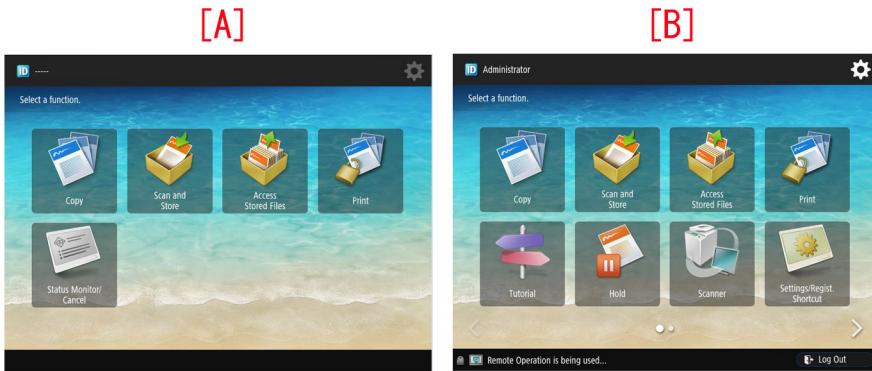
[A] shows the UI screen at the time of the symptom occurs. and [B], the normal UI screen.

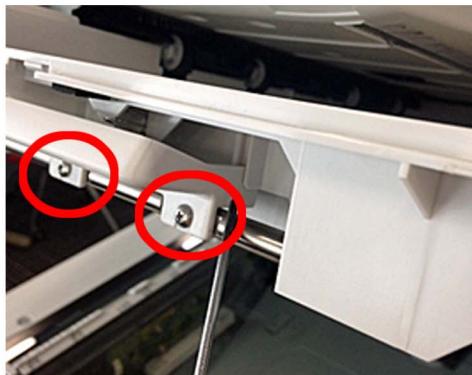
If the attaching section of the handle shaft [B] is broken, the shaft does not turn even if the handle is gripped. Therefore, the magnet attached to the shaft does not separate from the supporting plate on the copy board side, resulting in the above-mentioned symptom.

Photo [A] shows the handle attached correctly, and photo [B] shows the handle with the shaft mounting section broken.

Prepare the ADF handle set (FM1-V005-000) [1] that was set up exclusively as a service part, and replace the handle and the shaft by following the procedure below.

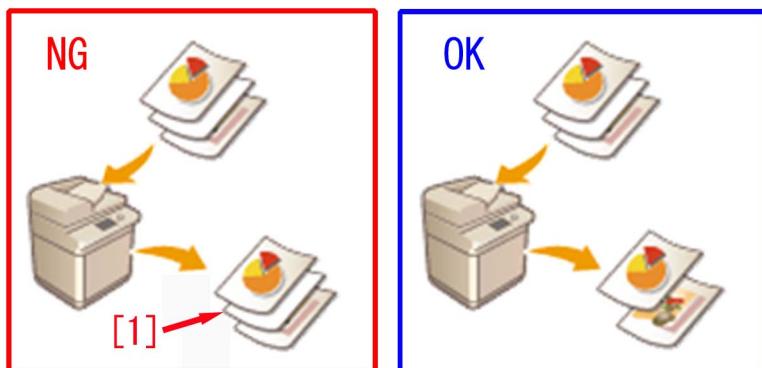
Blank pages may be mixed [1] (Skip Blank Originals fails) even if "Skip Blank Originals" is selected in Scan and Send/Scan and Store (Advanced Box).

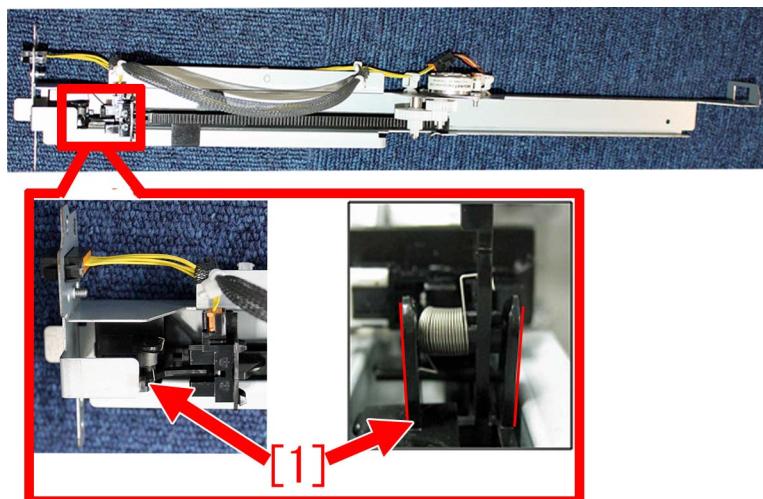
Though in rare cases the detection flag holder [1] of the photo sensor assembly is loose. For this reason the detection flag comes off, then the detection does not work properly and results in the above mentioned symptom.

When the aforementioned symptom has occurred, prepare a new photo sensor assembly (FM4-0897-010) and replace with it following the procedure below.

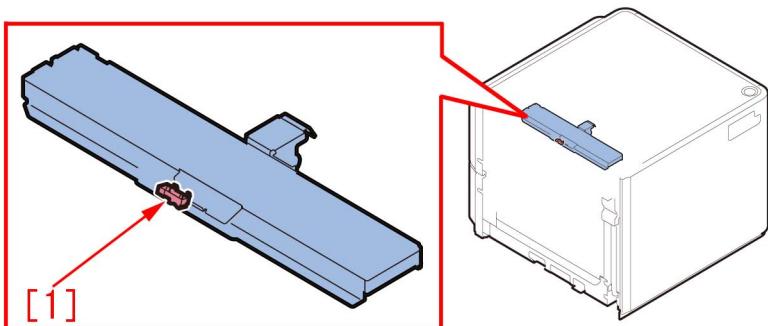
The deck pull-out sensor [1] of the pickup unit may incorrectly detect the reflected light of the adjacent deck pull-out roller feeder guide as paper, resulting in the above-mentioned symptom.

When the aforementioned symptom has occurred, prepare and replace with the lower feed guide [2] (FL0-2918-000) to which the black sheet [1] is affixed following the procedure below.

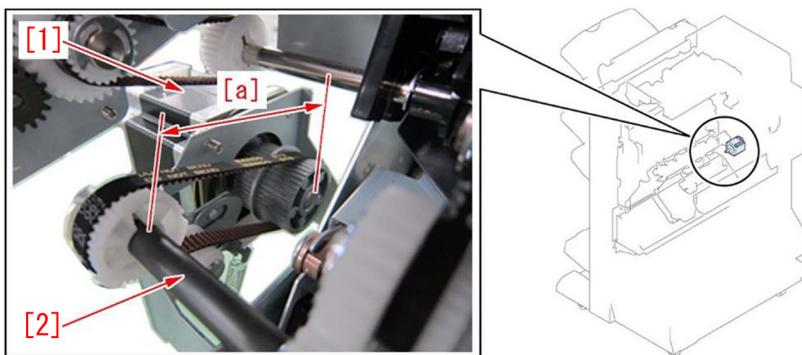
When the belt roller [2] of the process upper guide tilts to the processing feed motor (M26) [1] side, the distance between the shafts [a] becomes smaller and makes it easier for the timing belt to get loose. When the timing belt gets loose, a meshing failure occurs between the timing belt and the gears, resulting in the above symptom.

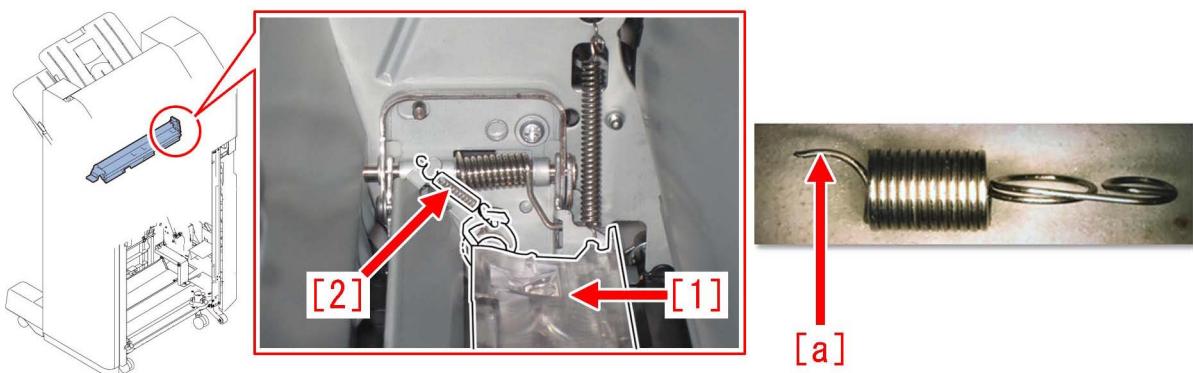
When a load is applied by any factor to the tension spring [2] which is lifting the escape inlet flapper [1], the tension spring is broken [a], and the escape inlet flapper descends and blocks the feed path toward the stack tray (processing tray). If paper is fed in this state, it is caught by the escape inlet flapper, resulting in the above-mentioned symptom.

When the above-mentioned symptom occurs, check the tension spring of the escape inlet flapper by following the steps below. If the tension spring is broken, prepare the new-type tension spring (FE4-7044-010) and replace it by following the steps below.
[Reference] Work procedure is different depending on the model.

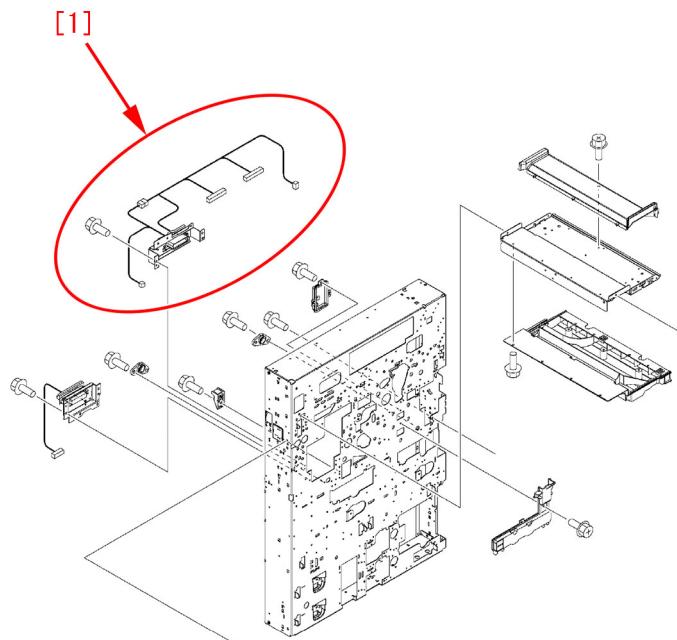
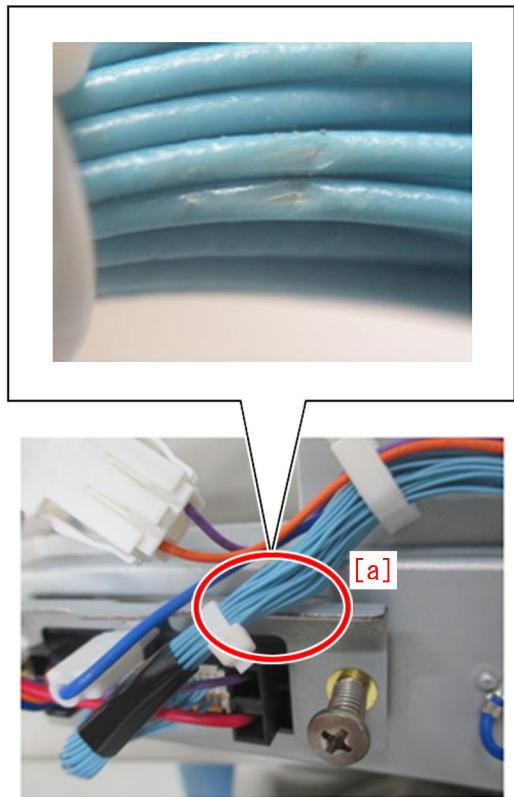
The fixing drawer cable [1] comes in contact with the sheet metal [a], and the cable coating is broken and short-circuited to cause the above-mentioned symptom.

[Reference] There was a case that the short-circuit caused the defective main drive driver PCB assembly and the relay PCB assembly.

If the above-mentioned symptom occurs, replace the fixing drawer cable with the new type of the fixing drawer cable (FM3-7351-020) having the additional protective tape to prevent the coating breakage.

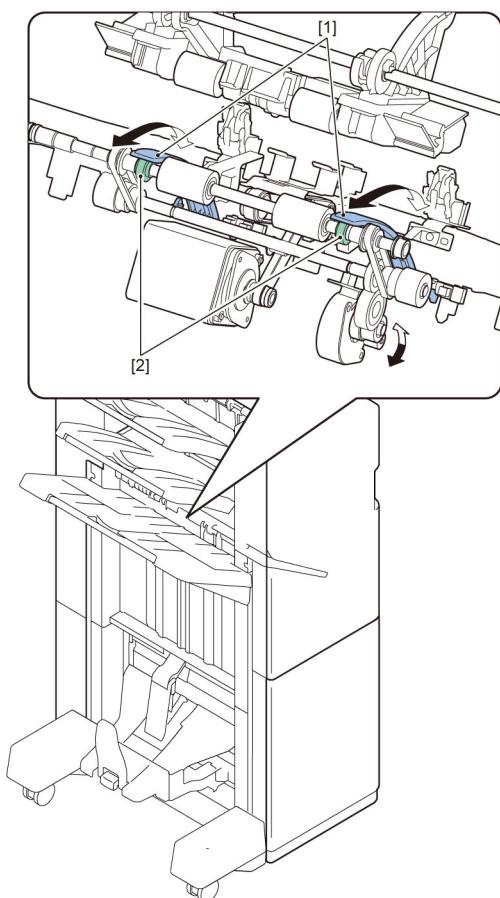
- When the rack of the front/rear tray auxiliary guide [1] does not engage properly with the pinion gear [2], and this condition has brought malfunction.

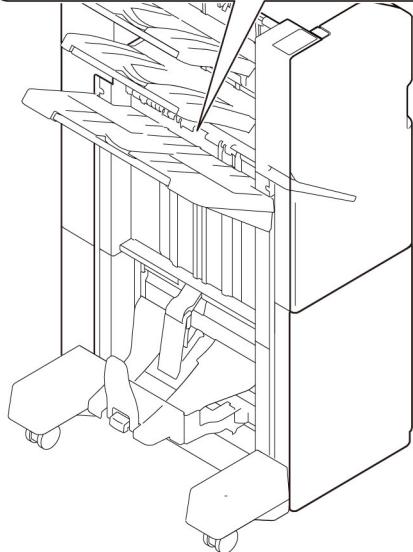
- When the clearance of the mounting of the lower stack delivery roller [1] is so wide that the bearing [2] has come off.

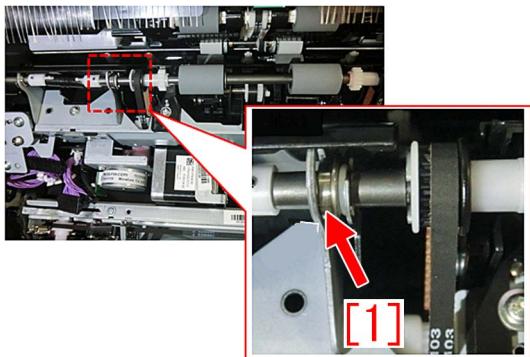
The figure below shows a condition where the bearing [1] has come off.

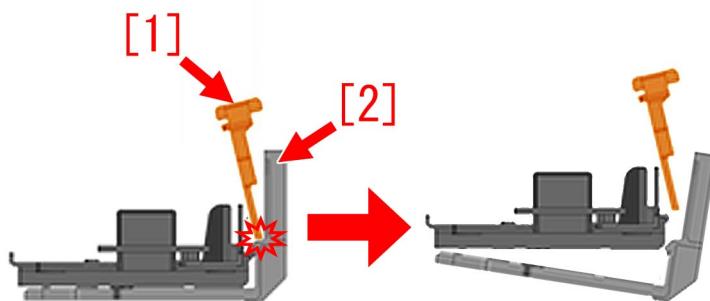
If the scanner fixation tool [1] is inserted obliquely when moving the main body, the tool becomes in a state where it is pressing the flat cable unit [2]. If the main body is moved in this state, the flat cable unit [2] may be detached, which may cause the above-mentioned symptom.

Fig.[A] shows the state where the scanner fixation tool [1] is inserted in a correct and straight way.

In addition, if the fixing claw [a] of the flat cable unit is broken, replace it with the new flat cable unit (FM0-0482-000).

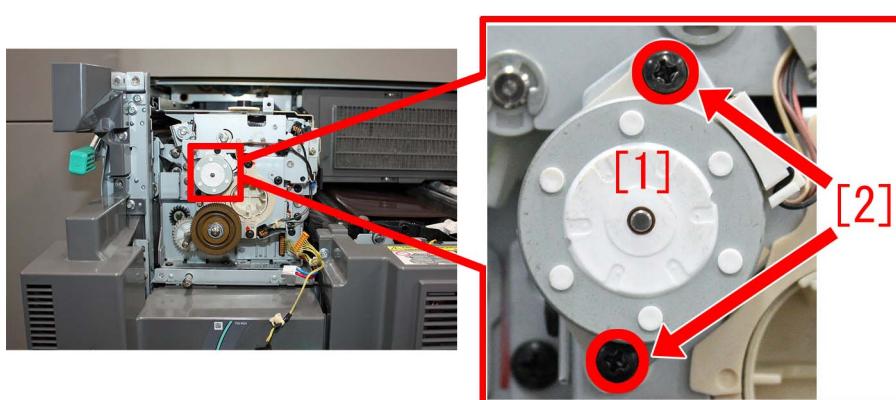
The screws securing the fixing shutter motor are loosened and come off after some endurance time has elapsed and from vibration, then the fixing shutter motor becomes unable to be driven the fixing shutter and ends in the above mentioned symptom.

The Fig.[A] shows the previous screw and Fig.[B], the screw with washer to be replaced with.

When the above mentioned symptom has occurred, replace the screws that are securing the fixing shutter motor with the screw with washer (XB2-8301-009) referring to the service manual.

- 1) Pull out the Fixing Feed Unit.
- 2) Remove the Fixing Front Cover and the Fixing Drive Unit 1.
- 3) Replace the 2 screws [2] that are securing the fixing shutter motor [1] with the screw with washer (XB2-8301-009).
