Symptoms & Solutions

For the imageRUNNER ADVANCE 8105 Series

A description of the Top Service Issues experienced by iR ADV 8105 Series service techs with an explanation of the solutions that have resolve each issue.

Issued October 2012

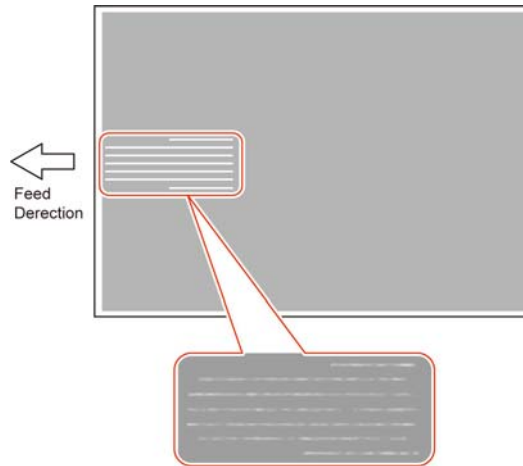
White lines in the vertical scanning direction (uneven development) sometimes occur on a halftone image after the Developer Assembly is replaced.

If toner is not spread evenly on the Lower Developer Cylinder, white lines in the vertical scanning direction may occur. This symptom can occur if toner is not stirred at installation or when a new Developer Assembly is replaced.

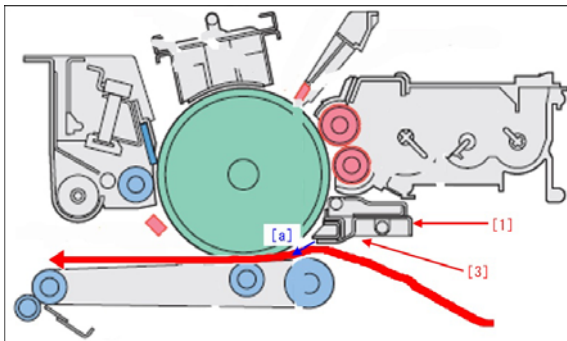
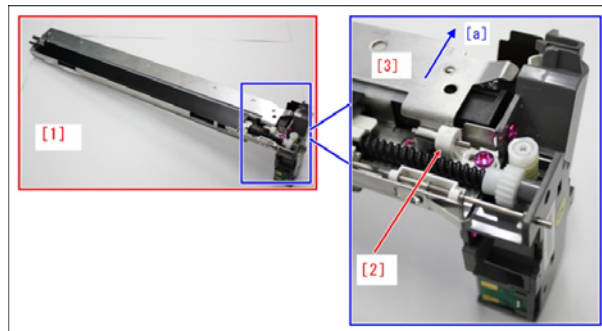
The Guide Stopper [2] of the Pre-Transfer Charging Assembly [1] is deformed, causing the Pre-Transfer Guide [3] to slip out of the normal position and become closer to the ETB [a]. As a result, the toner on the surface of the ETB may adhere to the Pre-Transfer Guide and can result in the leading edge of paper to become soiled.

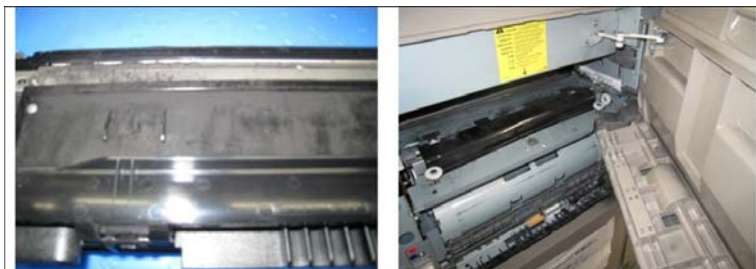
When either removing or installing the Developer Assembly, toner material is dumped in and around the Developer Assembly creating a dirty image to occur.

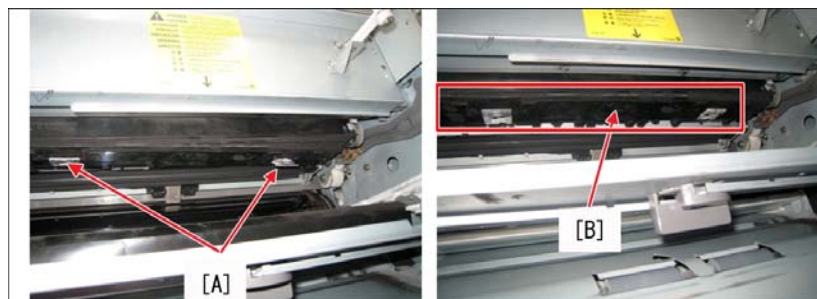
The Spring of the Shutter Arm [A] can come off the Developer Assembly if forcibly removed. If this should occur, the left Buffer Shutter [B] can open upon detaching the Developer Assembly creating toner to leak from the Buffer Unit.

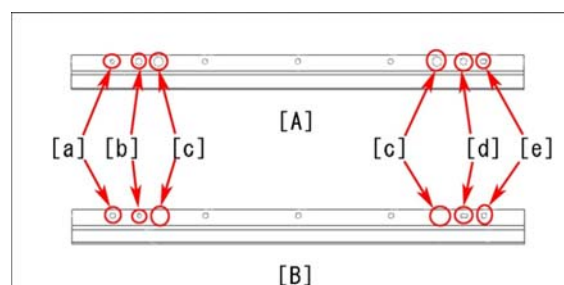
Due to backlash in the screw-tightening of the Blade Retainer Plate [1] for the Cleaning Blade, contact failure may occur between the Cleaning Blade and the Drum.

[e], change the long hole for the installing screw to the circular hole.

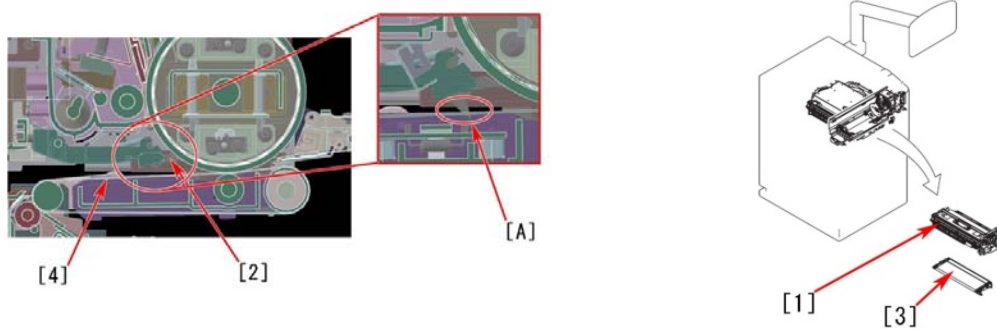
Stained image can occur if the Separation Claw of the Process Unit (AP Kit) [1] comes in contact with the ET Belt [3].

The Separation Claw [2] in the Process Unit (AP Kit) [1] which is installed to prevent paper from going into the Drum may come in contact with the ET Belt [4] upon a poor paper separation because the range of movement of the Separation Claw is wide. The toner of the transferred image is scraped off by this contact and the outcome image is stained. Also, when the ETB [4] is damaged or torn completely from the contact, the image will not be transferred or jam symptoms are induced. Figure [A] shows the contacting parts.

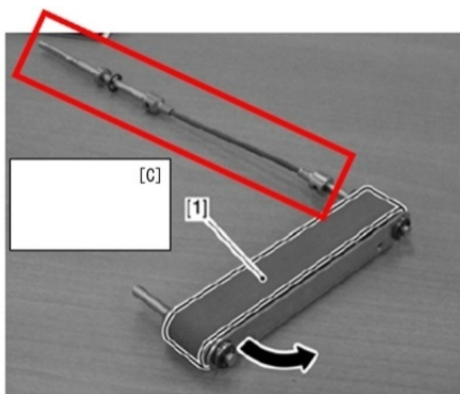
[C] Flexible Shaft

The Entrance Aligner Drive Belt is not rotating. All other drive belts driven by M3 (Transport Motor) are rotating normally. Closer observation will show that the Flexible Shaft (FC3-3778-000) is damaged and therefore, unable to drive the Entrance Aligner Drive Belt (green belt).

Replace the Flexible Shaft (FC3-3778-000)

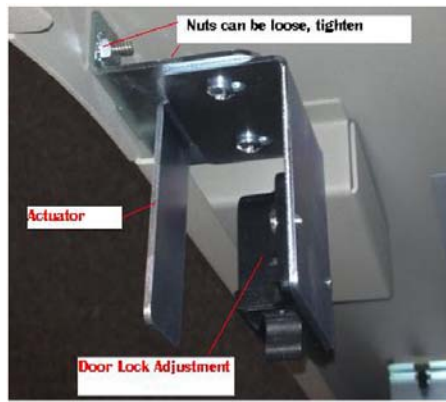
When running punch jobs through the Professional Puncher-C1, the machine will jam after approximately 20 to 50 punches. The main engine will indicate that an 1152 jam code has occurred. Upon inspection of the paper in the punch path, there is no damage to the paper. It is also observed that Pro Punch-C1 will hesitate when the jam occurs.

Ensure that Front Door Interlock Actuator Arm is not loose. If there is play in Door Actuator when Pro Puncher-C1 is punching, the vibrations of the device can intermittently cut-off the 24VDC supply voltage. Tighten the Door Actuator so there is no play. The illustration below shows the nuts of the Actuator Bracket and door lock adjustment that require tightening.

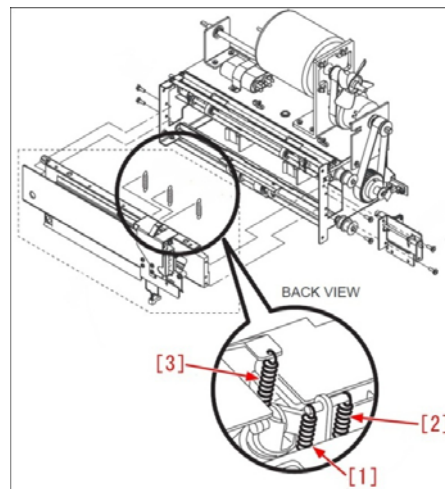
The jam occurred due to an operational defect of the back gage caused by breakage and detachment of the brown spring [1] attached to the back gage unit.

[Reference] The same symptom occurs when the red spring [2] or the blue spring [3] is detached.

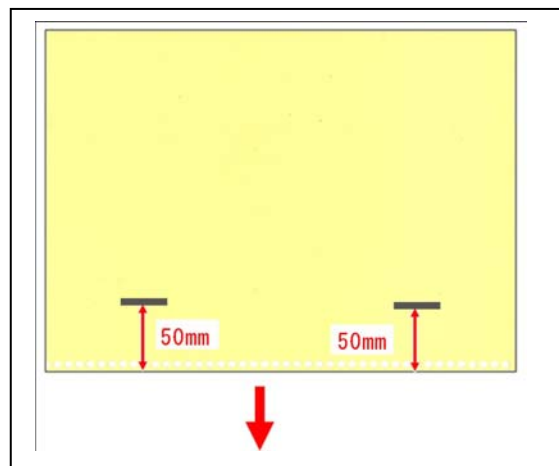
During punch operation of the Professional Puncher-C1, there may be two (2) roller marks (18mm x 2mm) on the front side of paper 50mm from its edge. The sample below is an illustration.

In the process of the Professional Puncher-C1 punching holes on paper, the puncher feeds the paper up to the punch area, and stops feeding once to punch holes. During the process, the drive roller was performing idle rotation on paper, and the same soil on the surface of the drive roller was found on the paper.

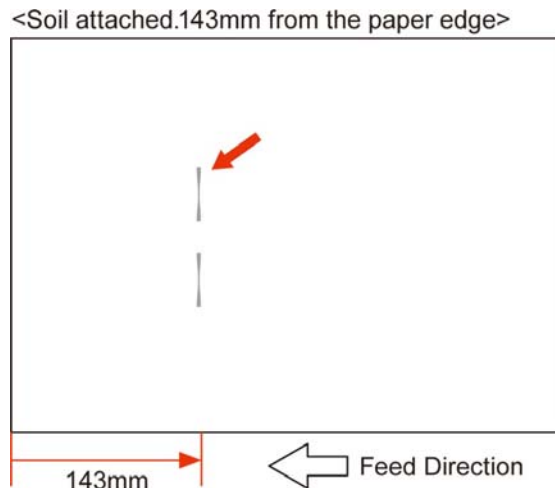
Soils corresponding to the width of the Registration Front Roller may occur at approximately 143mm from the lead edge of the paper.

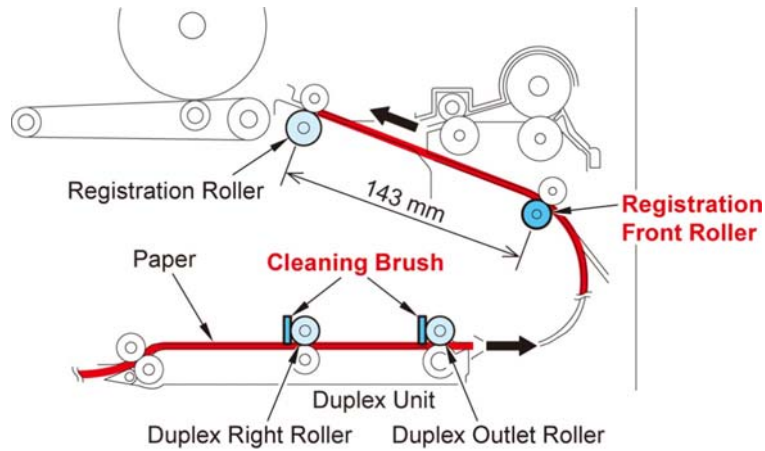
The Duplex Unit has 4 Cleaning Brushes that come into contact with the Duplex Right Roller and the Duplex Outlet Roller. Contamination caused by paper dust and toner will gradually attach to the surface of the Registration Front Roller. As paper stops at the Registration Roller due to registration control, the rotating Registration Front Roller will continue to turn on the stationary sheet, creating marks corresponding to the roller width approximately 143mm from the edge of the paper.

Proceed with the following steps to replace the Cleaning Brushes that contact with the Duplex Right Roller and the Duplex Outlet Roller and clean the relevant portions.

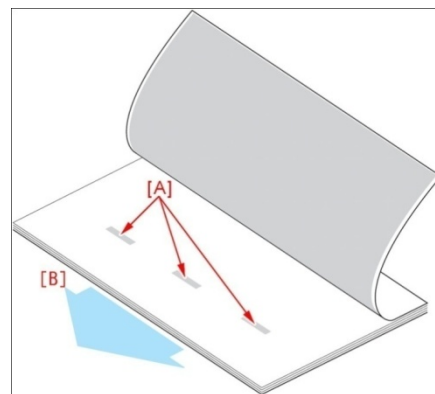
In a machine with Staple Finisher-D1 or Booklet Finisher-D, soiling at the back of the sheet [A] may occur when shift mode or staple mode is used.

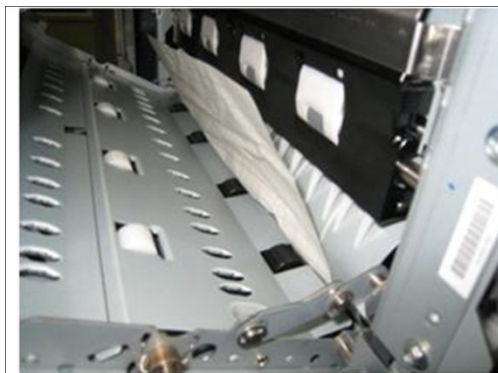
0115 Jam occurred at the entrance of the Duplex Path when duplexing.

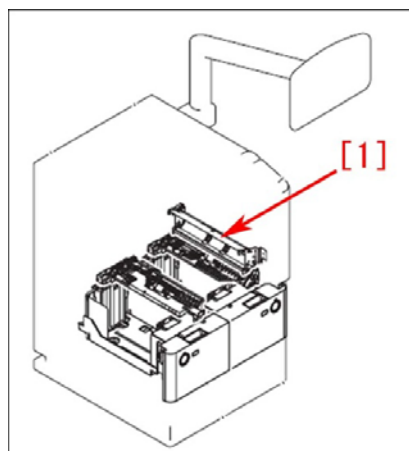
Paper may not feed properly into the Pre-Registration Guide [1]. A 0204 or 0208 Jam code may occur.

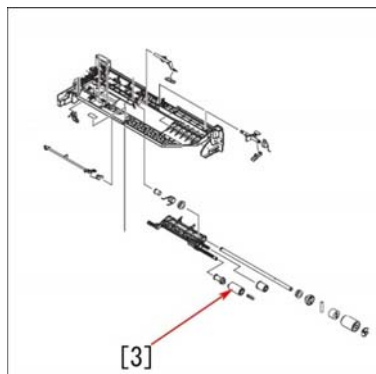
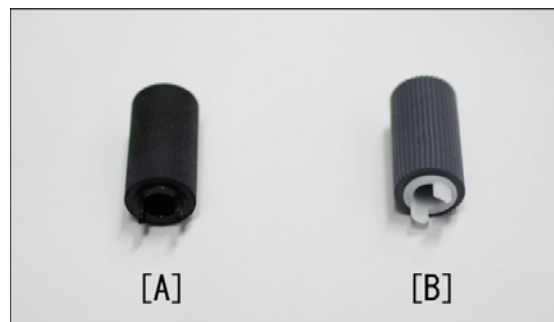
Because the friction coefficient was lowered due to adhesion of calcium carbonate contained in a paper; the surface of the black Pickup Roller in the Right or Left Deck pickup roller may become worn.

Note: Both the black Pickup Roller [A] and the Gray Pickup Roller [B] have been used on the machine's production line. Therefore, the abrasion of the Pickup Roller in machines with the Black Pickup Roller may wear out at an earlier stage.

When the symptom occurs, replace the pickup roller (FC5-2524-000).

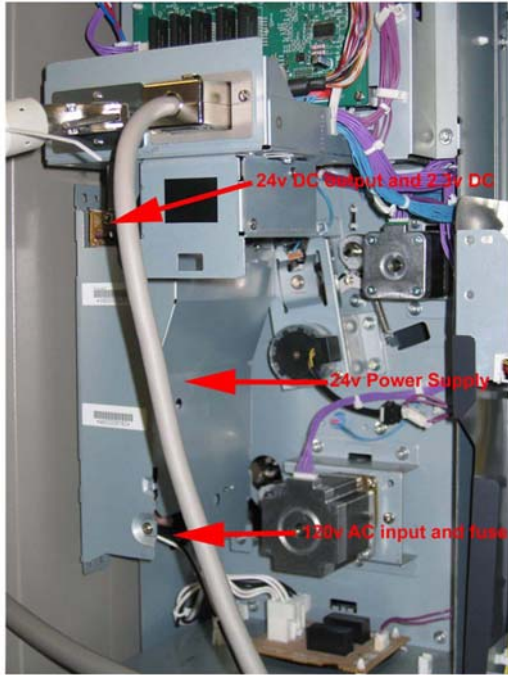
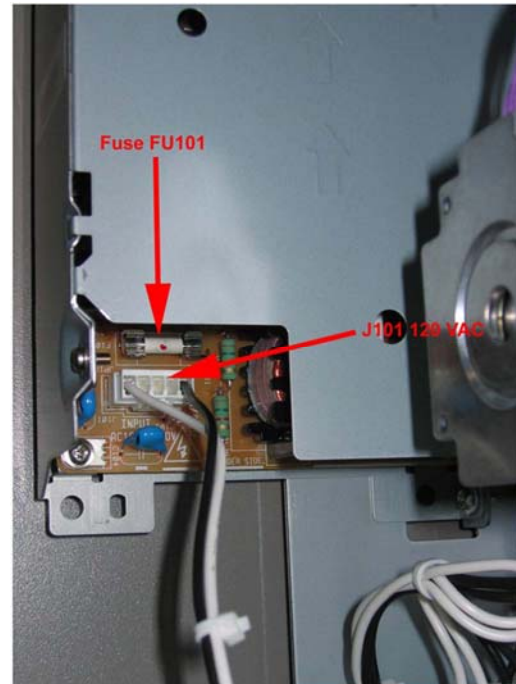
Confirmed 120 VAC input voltage is present to the 24V DC Power Supply at connector J101. Fuse FU101 on the 24V DC Power Supply is open. Replacing FU101 did not fix the error code. The following images show the location of the 24V DC Power Supply, FU101 and connector J101 on the rear side of the Integration Unit.

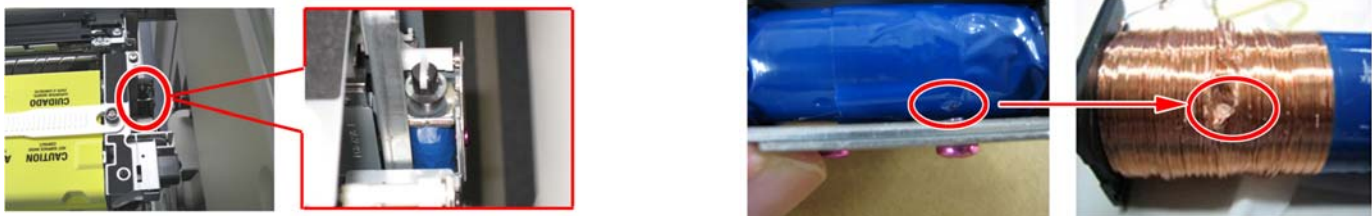
Screws (M3 x 6) were installed instead of screws (M3 x 4) for mounting the Reverse Solenoid Assembly (SL5).
By using the wrong screws may damage the Coil inside of the Reverse Solenoid Assembly.

Replace the Reverse Solenoid Assembly (FM4-5141-000) (SL5) and install it with screws (M3 x 4).

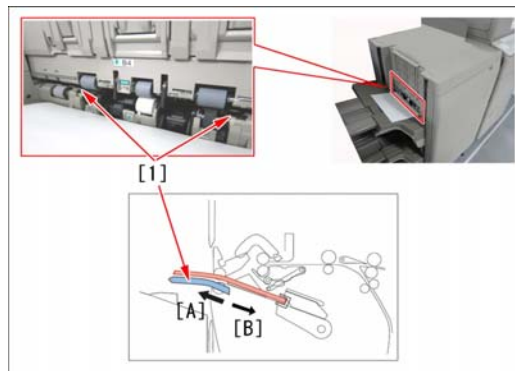
- E583-8001: The tray auxiliary guide does not come off the tray auxiliary guide front/rear HP sensors when the tray auxiliary guide motor has been driven for 3 seconds.
- E583-8002: The tray auxiliary guide front/rear HP sensor does not detect the tray auxiliary guide when the tray auxiliary guide motor has been driven for 3 seconds.

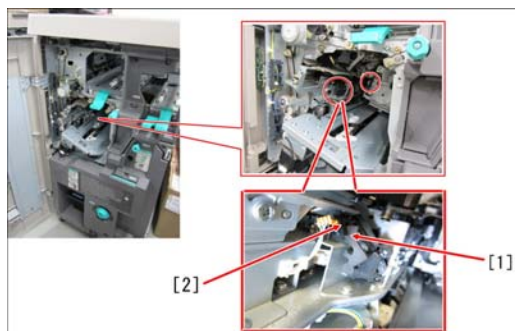
The position of the tray auxiliary guide is detected by the sub guide flag [1] and photo sensor [2]. The moving range of the sub guide flag becomes less than intended, which causes a failure to correctly detect ON/OFF by the photo sensor.

Prepare the two, new type sub guide flags (FC9-3081-010), and perform a replacement work by following the steps below. [A] is the old type and [B] is the new type.
