Troubleshooting Guide

imageRUNNER ADVANCE

C5560 Series

April, 2017
OIP Field Quality Assurance Div.

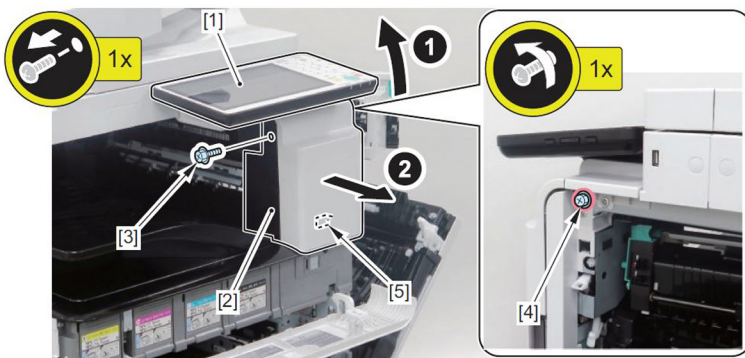
The connector [1] on the inner side of the toner bottle inner door interferes with the mold of the bottle front inner guide [2], and the connector cannot be fully inserted and the above-mentioned symptom may occur.

- 1) Removing the ITB Unit
- 2) Removing the Process Unit
- 3) Pull up the Control Panel [1] and remove the Right Front Cover [2].
 - 1 Screw [3] (to remove)
 - 1 Screw [4] (to loosen)
 - 1 Claw [5]

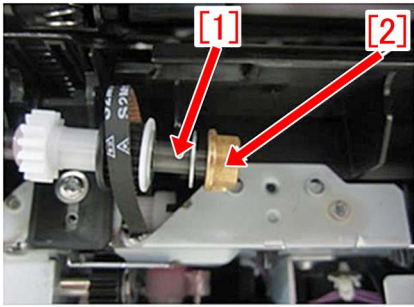
- 2) Operation failure of the front/rear tray auxiliary guide due to large clearance of the mount of the lower delivery roller [1] dislocating the bushing [2] on the rear side.

4) Remove the bushing [2] from the lower delivery roller shaft [1].
