Troubleshooting Guide

imageRUNNER ADVANCE

8500/6500 Series

April, 2018
OIP Field Quality Assurance Div.

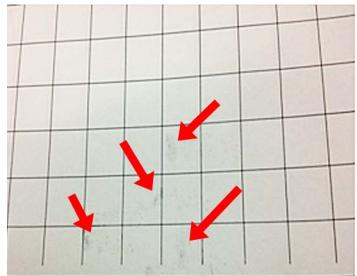
On the machines with the serial number earlier than the following countermeasure cut-in serial number in factory, soiled image [A] or blank image [B] may occur directly after machine installation or developing assembly replacement.

If there is a fault in the surface finishing of the developing assembly lower sleeve, the toner is charged more than necessary. Therefore, toner clump [a] may occur especially in the environment of low temperature and low humidity, resulting in the above-mentioned symptom.

Prepare the new-type developing assembly (FM4-5429-010) with the surface finishing process of its lower sleeve changed, and replace it by referring to service manual.

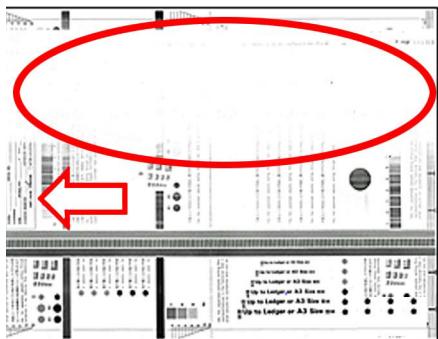
Poor density or white band image may occur in the machine earlier than the following countermeasure cut-in serial numbers in factory.

Below is a sample of image with white band phenomenon. Arrow shows the paper feeding direction.

When the stirring sheet [1] of the second stirring rod contacts the container, a stress concentrates to the base of the boss, which is connected to the 20T gear [2]. Repetitive stress may lead to breakage of the stirring rod, and toner will no more be stirred or supplied, resulting in the above mentioned phenomenon.

3) If necessary, prepare and replace with a new type of either a stirring rod (FL3-2163-010) or a developing assembly (FM3-7384-020).

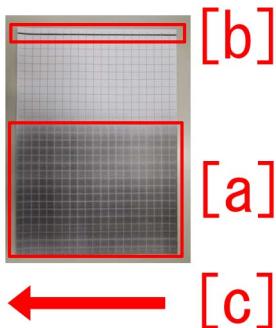
Foggy image [a] and black lines [b] may occur when copying and printing. The number of black lines and the location may not be constant.

The arrow [c] indicates the paper feed direction.

- 1) Remove the laser scanner unit by following Service Manual.
- 2) Check the dustproof glass inside the laser scanner unit. If the dustproof glass is detached, replace it with the new laser scanner unit. If it is not detached, look for another factor.
- 3) Return the laser scanner unit.

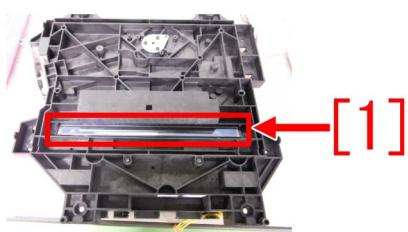
The double-sided tape attaching the dustproof glass [1] inside the laser scanner unit (FM3-7526-010/FM3-7531-010) is peeled off due to insufficient pressure, the dustproof glass detaches and drops inside the machine and it obstructs the optical path, resulting in the above-mentioned symptom.

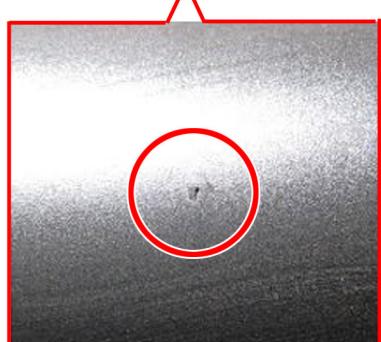
Scratches [a] on the developing upper/lower cylinder result in the aforementioned symptom.

Prepare and replace with a new developing assembly (FM4-5429-010).

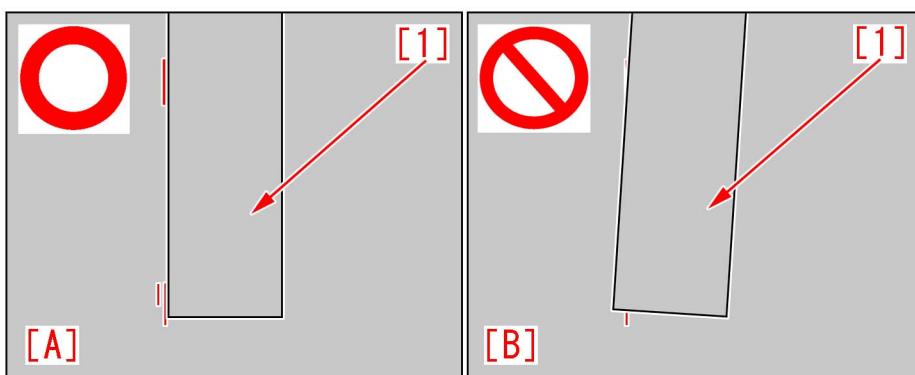
[A] shows the rear saddle alignment plate in the correct position located at the markings at the top and bottom. (The bottom marking is located in the center.)

[B] shows the skewed rear saddle alignment plate.

1-8-4) Loosen the fixing screw [1] of the rear saddle alignment plate and fix it according the markings on the bracket.
[Note] When fixing the rear saddle alignment plate, hold the rear saddle alignment plate to avoid having it attached in a skewed position.

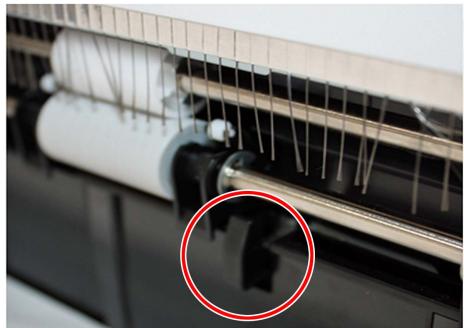
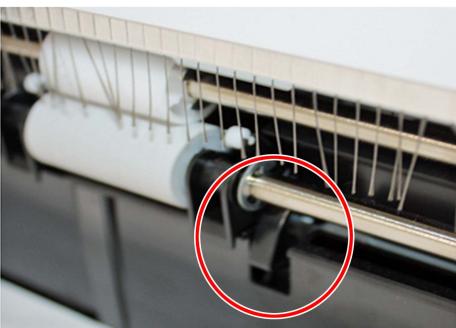
The figure [A] shows a condition where the sensor flag is at a normal position and the figure [B], the sensor flag is pushed towards the back side.

- 1) Turn the main power of the main body off.
- 2) Push the delivery roller [2] of the upper escape tray towards the rear side
- 3) Check if the sensor flag [1] comes back to a normal position by its own weight as shown in the figure [A].

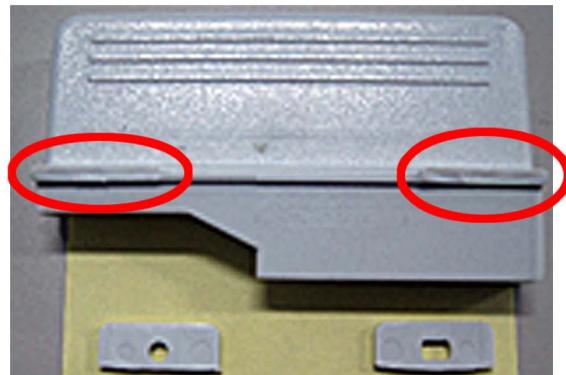
If the attaching section of the handle shaft [B] is broken, the shaft does not turn even if the handle is gripped. Therefore, the magnet attached to the shaft does not separate from the supporting plate on the copy board side, resulting in the above-mentioned symptom.

Photo [A] shows the handle attached correctly, and photo [B] shows the handle with the shaft mounting section broken.

Prepare the ADF handle set (FM1-V005-000) [1] that was set up exclusively as a service part, and replace the handle and the shaft by following the procedure below.

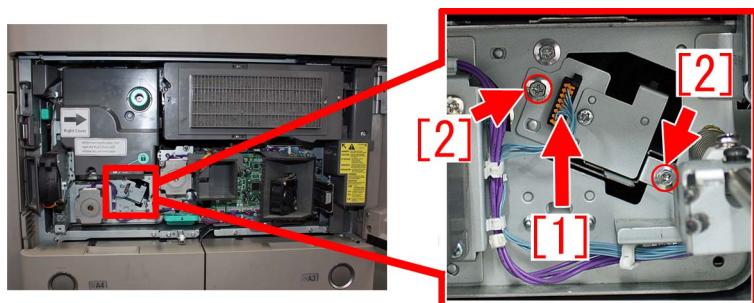
Though in rare cases the detection flag holder [1] of the photo sensor assembly is loose. For this reason the detection flag comes off, then the detection does not work properly and results in the above mentioned symptom.

When the aforementioned symptom has occurred, prepare a new photo sensor assembly (FM4-0897-010) and replace with it following the procedure below.

- 1) Referring to Service Manual, remove the fixing feed lever, the fixing feed right front cover, and the fixing feed left cover.
- 2) Pull out the connector [1] connected to the photo sensor assembly. Then remove 2 screws [2].

- 3) Pull out the photo sensor assembly to the front, and replace it with the new photo sensor assembly.
- 4) Install the items by reversing the procedure from step 2).

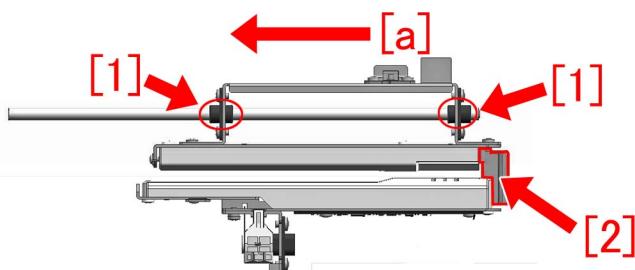
When the sliding load from the sliding part [1] inside the side registration sensor assembly is great, the side registration sensor assembly drive motor steps out and the position of the support [2] is displaced towards the front side of the product [a]. In the said condition, the paper contacts the support [2], would be skewed in delivery and may result in the aforementioned symptom.

When the above mentioned symptom frequents, prepare and replace with the new type side registration sensor assembly for each product referring to the service manual.

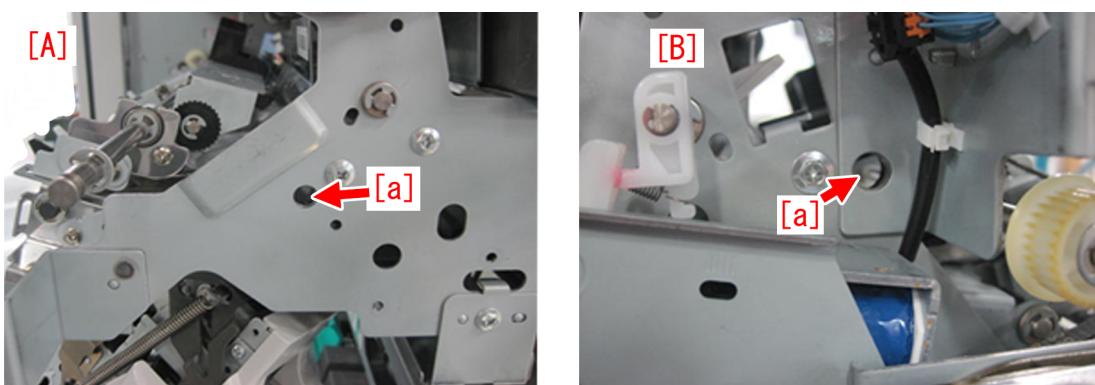
When the belt roller [2] of the process upper guide tilts to the processing feed motor (M26) [1] side, the distance between the shafts [a] becomes smaller and makes it easier for the timing belt to get loose. When the timing belt gets loose, a meshing failure occurs between the timing belt and the gears, resulting in the above symptom.

When the above symptom occurs, remove the paper delivery drive assembly (L) by following the procedure below. Then align the connecting holes of the upper dispose guide and the front plate/rear plate, and reattach the operation feed motor (M26) so that the distance between shafts of the belt roller in the upper dispose guide and the operation feed motor (M26) is appropriate. The following procedure starts from after the finisher being removed from the engine.

- 1) Refer to "Removing the front cover" and "Removing the rear cover" in Service Manual and remove both covers.
- 2) Be sure that the connecting holes [a] of the upper dispose guide and the front plate/rear plate are aligned.
The photo [A] shows the front plate and the photo [B] shows the rear plate.
 - If the connecting holes [a] of the upper dispose guide and the front plate/rear plate are aligned, the step 3) is not required, so proceed to the step 4).
 - If the connecting holes [a] of the upper dispose guide and the front plate/rear plate are not aligned, proceed to the next step.

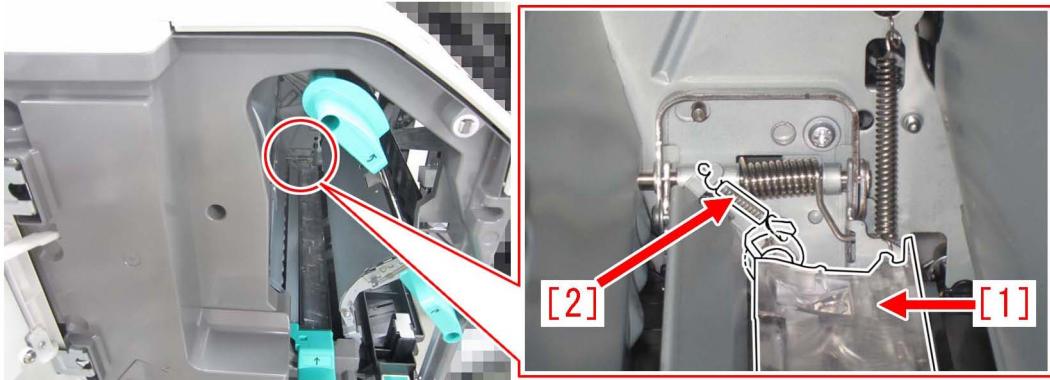
When a load is applied by any factor to the tension spring [2] which is lifting the escape inlet flapper [1], the tension spring is broken [a], and the escape inlet flapper descends and blocks the feed path toward the stack tray (processing tray). If paper is fed in this state, it is caught by the escape inlet flapper, resulting in the above-mentioned symptom.

When the above-mentioned symptom occurs, check the tension spring of the escape inlet flapper by following the steps below. If the tension spring is broken, prepare the new-type tension spring (FE4-7044-010) and replace it by following the steps below.
[Reference] Work procedure is different depending on the model.

[Note] If the punch unit is installed, shift the punch unit before starting the work.
a-2) Check the tension spring [2] attached to the escape inlet flapper [1].

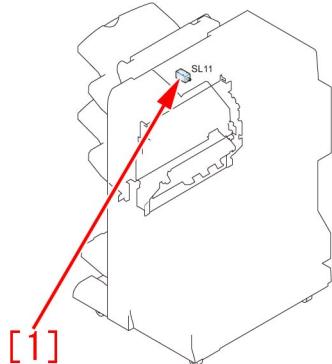
When pull in current value of the solenoid was insufficient and the installed position of estrangement solenoid unit (SL11) [1] was inappropriate, nip pressure of the postcard feeding rollers may be insufficient. This may lead to the above mentioned phenomenon.

b) Prepare and replace with a new type of estrangement solenoid unit (FM1-A170-010), following the procedure below. Note that the following procedure starts from where the finisher was removed from main body of a copying machine.

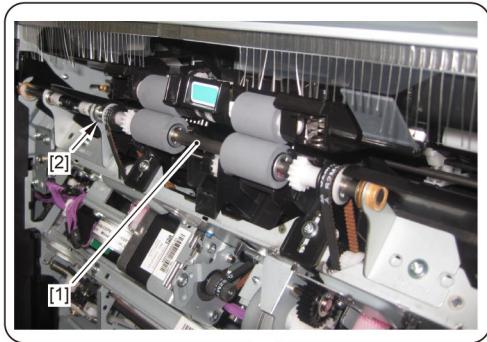
- When the clearance of the mounting of the lower stack delivery roller [1] is so wide that the bearing [2] has come off.

When the aforementioned symptom has occurred, check if the front/rear tray auxiliary guide works properly. If the front/rear tray auxiliary guide does not work properly, prepare the washer (XD1-1106-235), fix the dropped bearing of the lower stack delivery roller and adjust the mounting of the front/rear tray auxiliary guide holder following the procedure below.

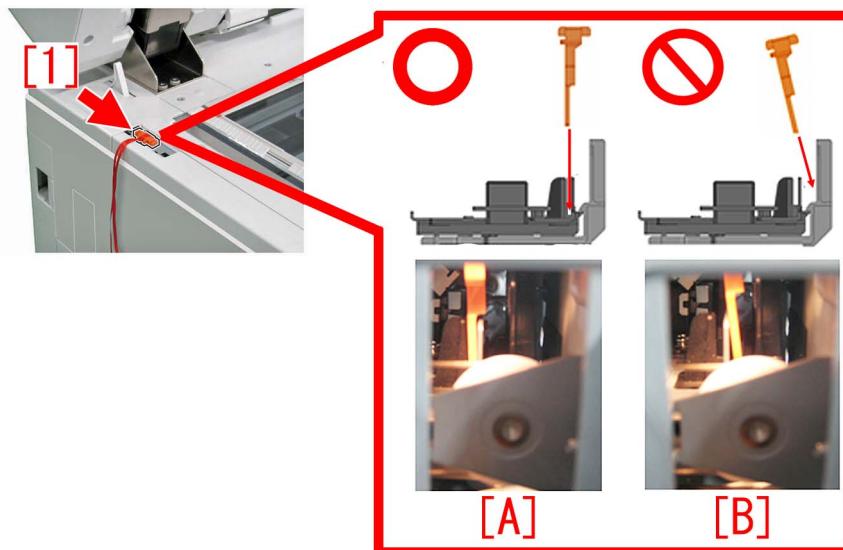
If the scanner fixation tool [1] is inserted obliquely when moving the main body, the tool becomes in a state where it is pressing the flat cable unit [2]. If the main body is moved in this state, the flat cable unit [2] may be detached, which may cause the above-mentioned symptom.

Fig.[A] shows the state where the scanner fixation tool [1] is inserted in a correct and straight way.

Fig.[B] shows the state where the scanner fixation tool [1] is inserted in a wrong and oblique way.

If the above-mentioned symptom occurs, check whether the flat cable unit is detached from the reader scanner unit. If it is detached, attach the flat cable unit correctly.

[Attention] If attaching the scanner fixation tool when moving the main body, insert it in a correct and straight way.

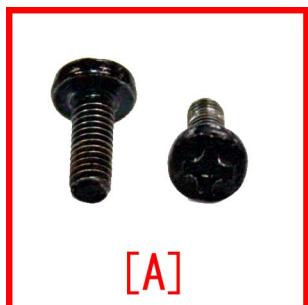
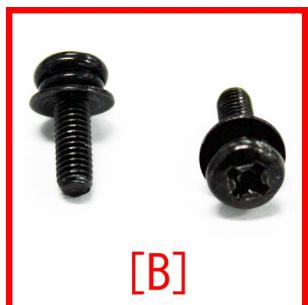
The screws securing the fixing shutter motor are loosened and come off after some endurance time has elapsed and from vibration, then the fixing shutter motor becomes unable to be driven the fixing shutter and ends in the above mentioned symptom.

The Fig.[A] shows the previous screw and Fig.[B], the screw with washer to be replaced with.

When the above mentioned symptom has occurred, replace the screws that are securing the fixing shutter motor with the screw with washer (XB2-8301-009) referring to the service manual.

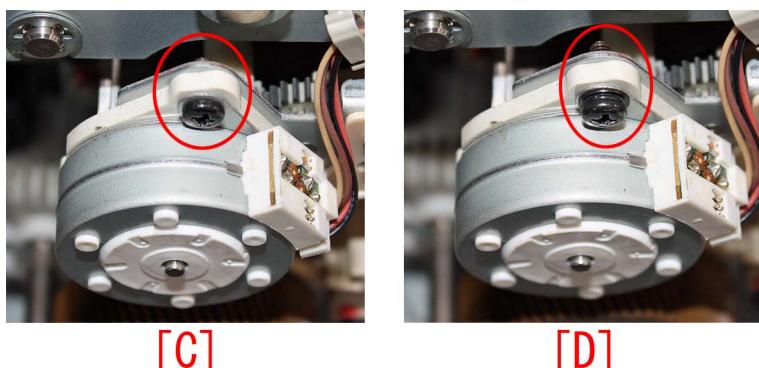
The Fig.[C] shows the securement with the previous screw and Fig.[D], with the screw with washer.

- 1) Pull out the Fixing Feed Unit.
- 2) Remove the Fixing Front Cover and the Fixing Drive Unit 1.
- 3) Replace the 2 screws [2] that are securing the fixing shutter motor [1] with the screw with washer (XB2-8301-009).

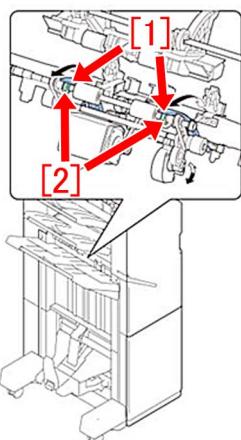
1) Operation failure of the front/rear tray auxiliary guide due to shift in engagement of the rack and the pinion [2] of the front/rear tray auxiliary guide [1]

7) Loosen the 2 screws [1], rotate the gear [2] in an arrow direction with a hand, pull out the front/rear tray auxiliary guide [3] for approx. 10 mm, and then tighten the 2 screws [1].

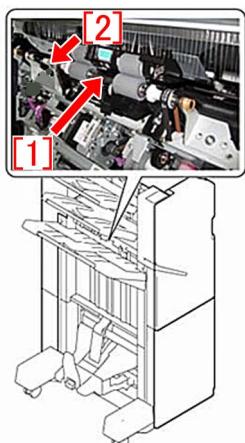
2) Operation failure of the front/rear tray auxiliary guide due to large clearance of the mount of the lower delivery roller [1] dislocating the bushing [2] on the rear side.

5) Attach the washer (XD1-1106-235) [3] between the E-ring [1] and the bushing [2] of the lower delivery roller. However, if the lower delivery roller is a new type, attaching the washer (XD1-1106-235) [3] is not required.

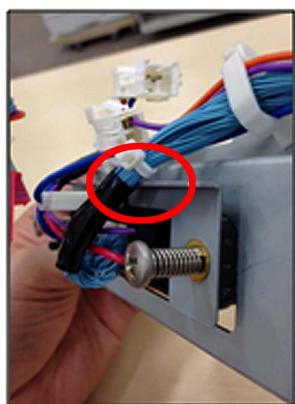
If a vibration is loaded to the fixing drawer cable (FM3-7351) on the back side of the main body or if the fixing/feeding assembly is removed and installed while the fixing drawer cable (FM3-7351) is pinched by the duct, the coating of the cable may be damaged, and this will lead to the above mentioned symptoms.

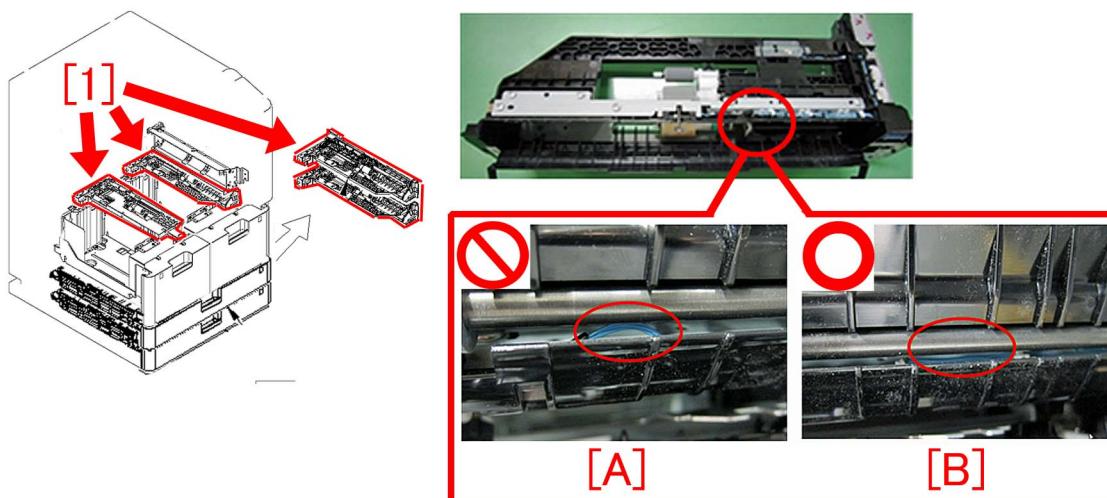
If the cable is in contact with the roller spindle for the pick-up assembly [1] and its coating is worn, a short circuit occurs and it results in the above-mentioned symptom.

Photo [A] shows the state of that bent cable is in contact with the roller spindle. Photo [B] shows the normal state of that the cable is placed straight.

When the above symptom occurs, check the cable adjacent to the roller spindle for paper pick-up assembly.

If the coating of cable has worn, the replacement of paper pick-up assembly or cable is required. If the coating of cable has not worn, check for the other causes.

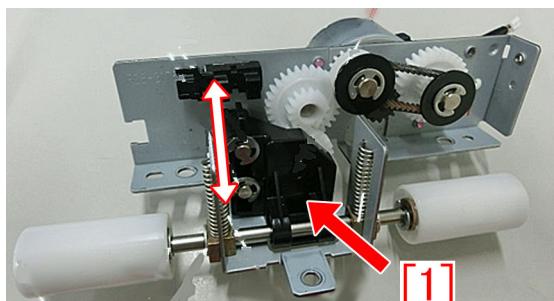
While the feed roller shaft is moving up and down to detect home position, if the estrangement rack [1] that holds the feed roller shaft inclines, the load from sliding increases and the feed roller shaft becomes unable to go back to home position, and this brings the aforementioned symptom.

When the above-mentioned symptom occurs, perform the work either A) Replacing the upper feeder assembly with the new type or B) Applying the grease to the feed assembly.

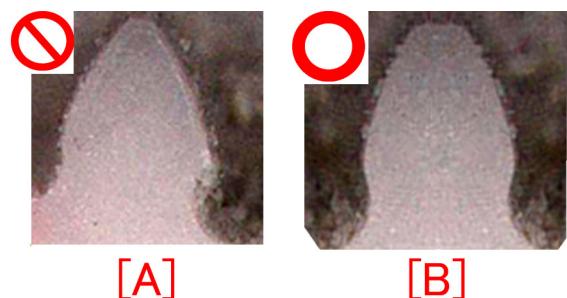
The picture [A] shows a shaved gear tooth in a triangle shape. The picture [B], a gear tooth in the normal shape.

If chipped/shaved teeth are observed, shift the phase of the gear position by rotating by 180 degrees at angle.

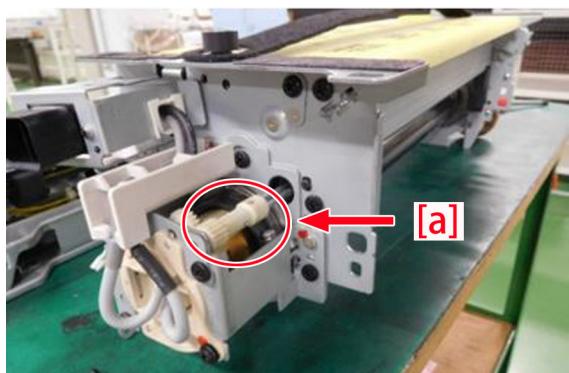
Due to deformation and burrs of a drive shaft in the upper fixing ass'y, the load (torque) may be increased to cause abnormal rotation, leading to the aforementioned symptom.

Rotate the drive shaft [a] in the fixing ass'y manually, in the clockwise/anti-clockwise direction until it stops. If the shaft does not rotate smoothly, refer to the service manual, prepare and replace with the new upper fixing ass'y (FM3-7358-060).

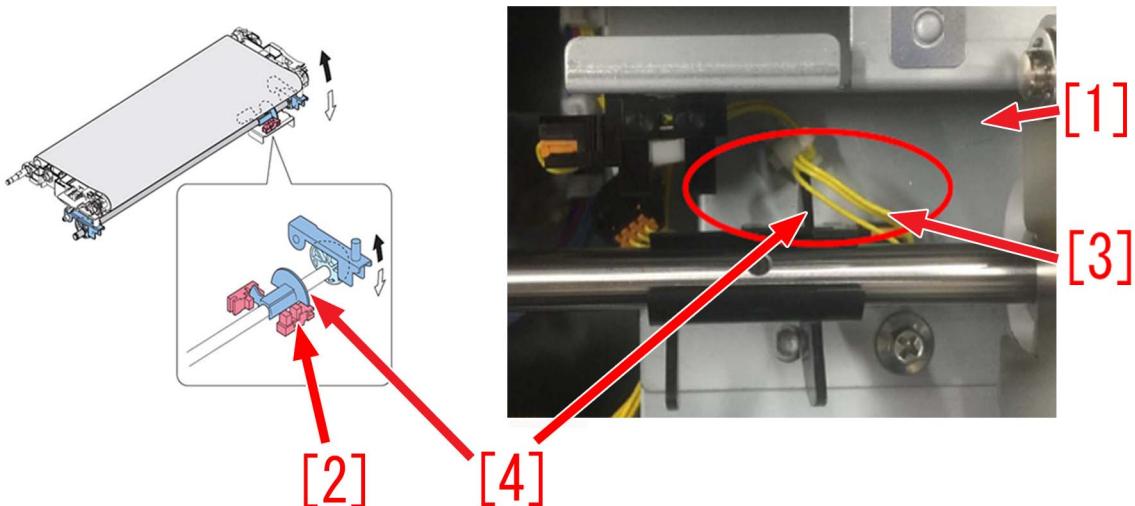
Harness [3] of the ETB disengage sensor [2] of the solenoid assembly [1] may interfere with a sensor flag [4], causing sensor flag rotation failure. This may lead to aforementioned symptom.

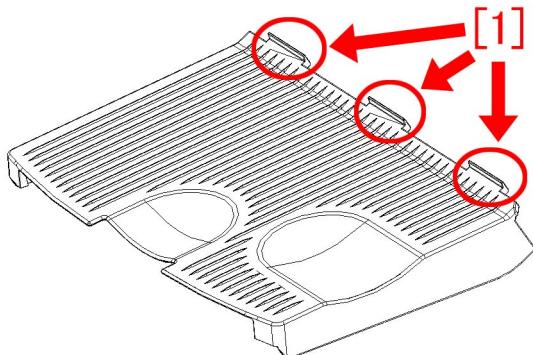
The copy tray hooks (claws) [1] may break on an engine whose serial number is earlier than the following countermeasure cut-in serial numbers in factory.

An overloading of output paper overcomes the designed strength of copy tray, and this induces the above mentioned symptom. The said symptom would not occur in the use where the stack volume in the tray is within the specification.

When the aforementioned symptom has occurred, replace the copy tray 1 [1] with new type which changed shape of the hooks (claws) and enhanced strength against weight.

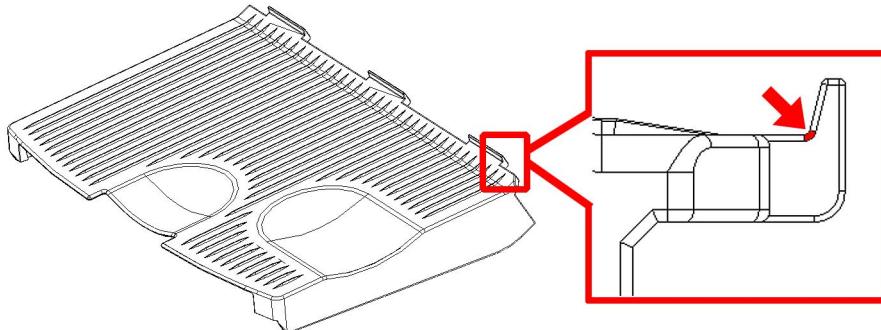
Figure [A] is the previous copy tray 1 and [B], the new type copy tray 1.
