Symptoms & Solutions

For the imageRUNNER ADVANCE 8105 Series

A description of the Top Service Issues experienced by iR ADV 8105 Series service techs with an explanation of the solutions that have resolve each issue.

Issued October 2012

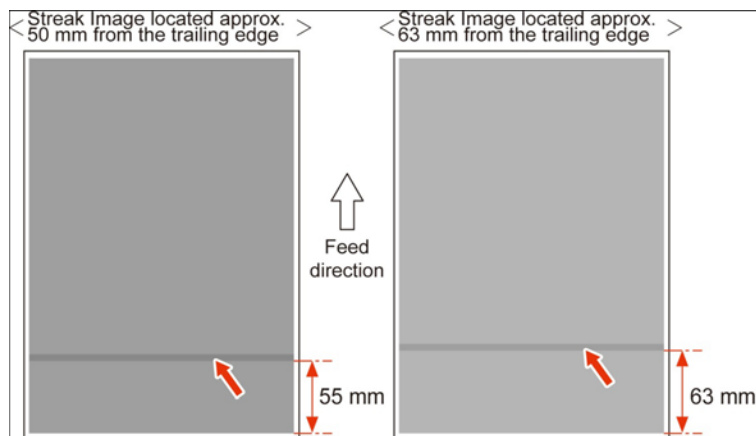
Lines in the horizontal scanning direction may occur at the trailing edge of the image after replacement of ETB.

COPIER > ADJUST > FEED-ADJ > TBLT-SPD > Fine adjustment of ETB speed

- If the line is approximately 55mm from the trailing edge, increase the value by 10.
- If the line is approximately 63mm from the trailing edge, decrease the value by 10.

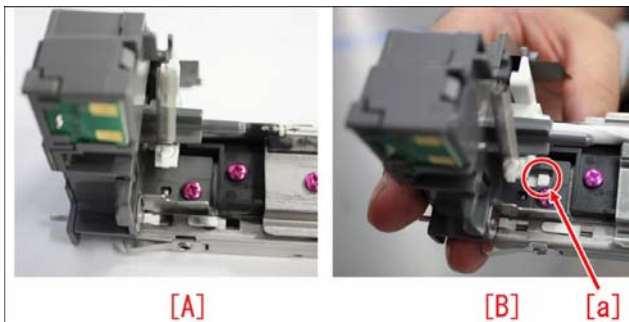
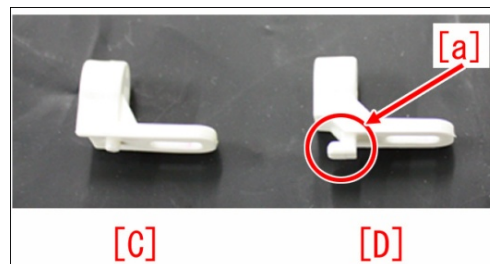
The photo [A] shows the old type, and the photo [B] shows the new type; [a] shows the hook part of the new-type guide stopper.

The new-type Pre-Transfer Charging Assembly (FM4-3149-010) which is the countermeasure for preventing the Guide Front Stopper from becoming deformed has been introduced.

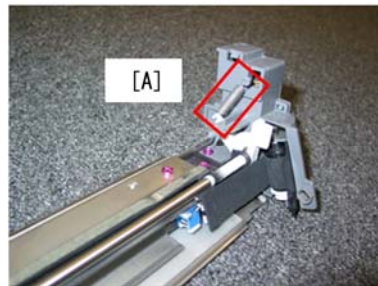
If the Return Spring [A] of the Pre-Transfer Corona Assembly, Dust Collection Roller should disengage from the actuator perform the following:

Reattach the Spring [A] and vacuum out the Pre-Transfer Assembly.

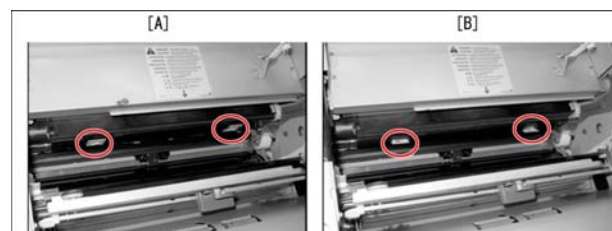
[A] Shows the Shutter Arm Closed

[B] Shows the Shutter Arm Opened.

- 1) Remove the Developing Assembly and mount the Spring of the Buffer Shutter.
- 2) By hand, check if the Buffer Shutter can open and close freely. To see whether the Buffer Shutter is open or closed, check the location of the Shutter Arm.

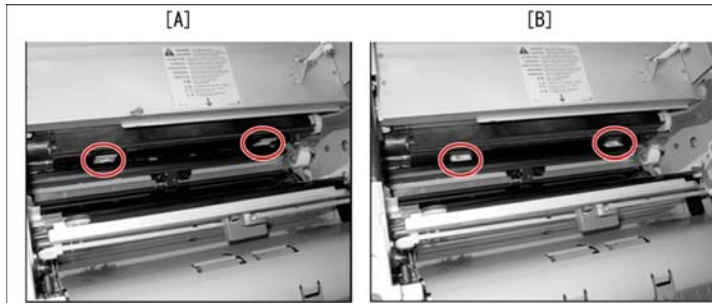
The Spring of the Shutter Arm [A] can come off the Developer Assembly if forcibly removed. If this should occur, the left Buffer Shutter [B] can open upon detaching the Developer Assembly creating toner to leak from the Buffer Unit.

[A] Shutter Arm Closed [B] Shutter Arm Open.

- 1) Remove the Developer Assembly.
- 2) Clean the Developer Assembly and the area around the Developer Assembly.
- 3) Reinstall the spring of the Buffer Shutter.
- 4) Make sure that the Buffer Shutter is closed.

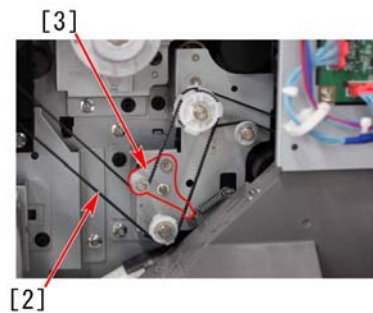
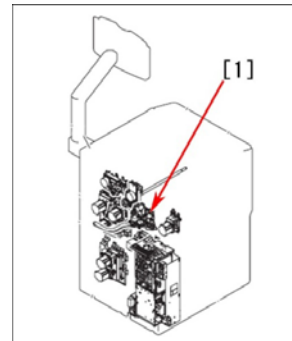
The Tensioner [3] in the Waste Toner Feed Assembly [1] applies appropriate tension to the Timing Belt [2]. If the Tensioner [3] is deformed due to excessive force the Timing Belt [2] may come off the Tensioner [3] and consequently the Drum Cleaning Assembly becomes unable to function. This causes symptom can cause waste toner to accumulate, creating soil on the image.

Replace the old type Tensioner [A] with the new type tensioner [B]. For this replacement, if the original Stepped Screw (FS5-9714-000) is used, appropriate tension may not be applied to the timing belt properly. Therefore, prepare the new type stepped screw (FS1-9010-020) and replace with it at the same time.

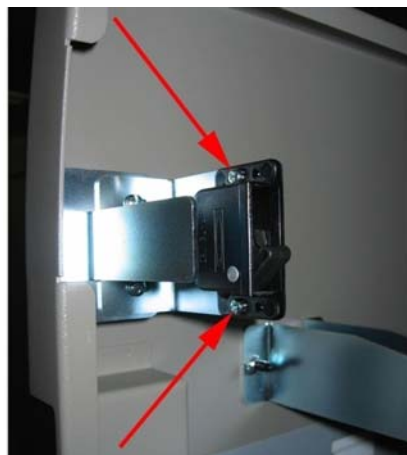
A 1F77 jam code can occur if the drives of the Professional Puncher-C1 do not turn. The voltage to the drive motors can intermittently be shut off if the screws that secure the Front Door Latching mechanism of the Hook of the Front Door Latch become loose

- 1) Tightening the screws of the Front Door Latching mechanism as shown in the illustration below.

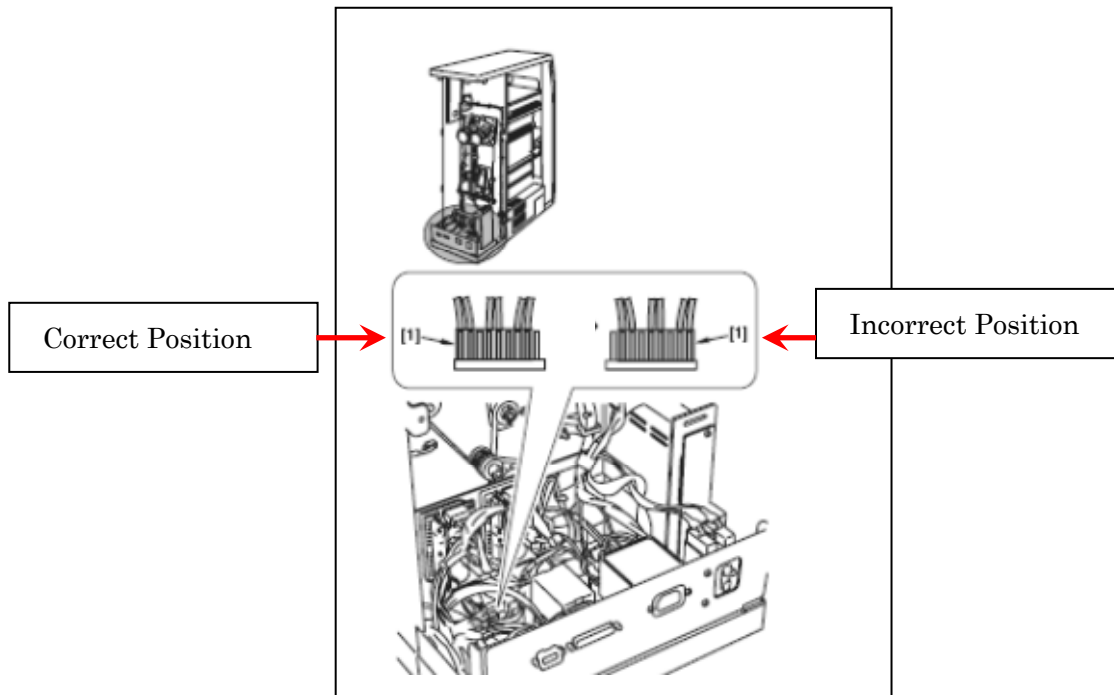
The Jumper Connector on the Punch Controller PCB was moved to the wrong position. The default position of the Jumper Connector is set for higher speed devices. Therefore for the imageRUNNER ADVANCE 8000 Series it is not necessary to move the Jumper Connector. Doing so will cause 1F77 jam to occur.

When observing the position of the Jumper Connector, if the furthers right pin is not exposed then the Jumper Connector is in the wrong position for the imageRUNNER ADVANCE 8000 Series. Therefore, move the Jumper Connector so that the furthest right pin is exposed.

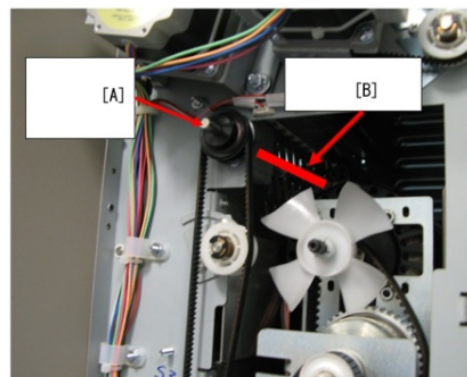
The Entrance Aligner Drive Belt is not rotating. All other drive belts driven by M3 (Transport Motor) are rotating normally. Closer observation will show that the Flexible Shaft (FC3-3778-000) is damaged and therefore, unable to drive the Entrance Aligner Drive Belt (green belt).

[C] Flexible Shaft

[1] Entrance Aligner Drive Belt

[A] Flexible Drive Shaft Gear Drive

[B] Flexible Shaft Location (Rear Side)

Replace the Flexible Shaft (FC3-3778-000)

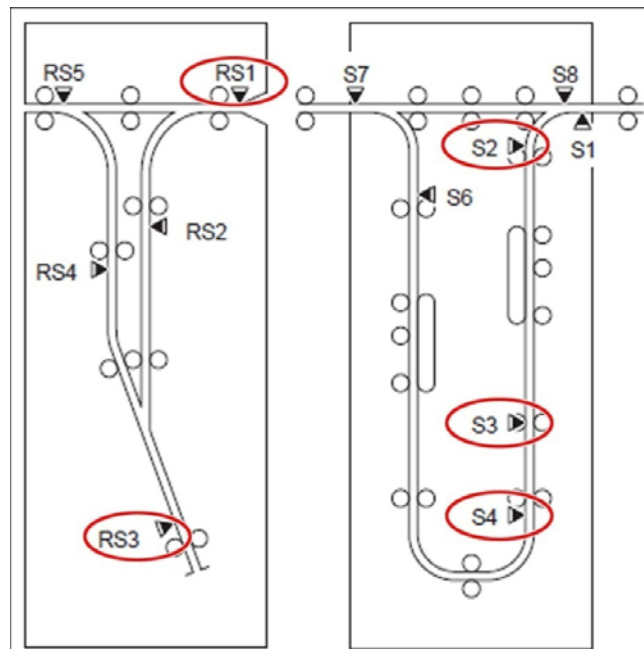
- 11B3/11B5/11B7/1F07/1FC2/1103/1164/1165/1166/1F5E/1F77/1152 Jam consecutively occurred.
- 11B3: Punch Path 1 Sensor (S2) Stationary Jam with ARCNET connection
- 11B5: Punch Path 2 Sensor (S3) Stationary Jam with ARCNET connection
- 11B7: Punch Path 3 Sensor (S4) Stationary Jam with ARCNET connection
- 1F07: Reverse Path 2 Sensor (RS3) Timing NG Jam with ARCNET connection
- 1FC2: Timing NG Jam with ARCNET connection
- 1103: Bypass 1 Sensor (RS1) Stationary Jam with ARCNET connection
- 1164: Punch Path 1 Sensor (S2) Stationary Jam with IPC connection
- 1165: Punch Path 2 Sensor (S3) Stationary Jam with IPC connection
- 1166: Punch Path 3 Sensor (S4) Stationary Jam with IPC connection
- 1F5E: Reverse Path 2 Sensor (RS3) Timing NG Jam with IPC connection
- 1F77: Timing NG Jam with IPC connection
- 1152: Bypass 1 Sensor (RS1) Stationary Jam with IPC connection

The jam occurred due to an operational defect of the back gage caused by breakage and detachment of the brown spring [1] attached to the back gage unit.

The surface treatment of the Brown Spring is changed to the one that Brown coating is applied on top of nickel-plating, which can make the Spring difficult to be broken.

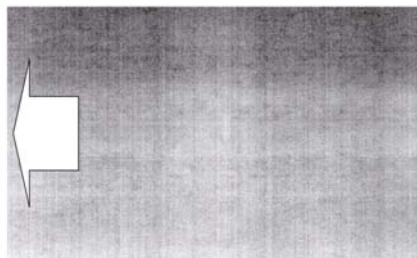
Crepe mark

This symptom may occur on all images, especially on halftone images with the following conditions:

As the temperature on the edges of the Upper Fixing Roller increase during continuous print, the edges of the Pressure Roller expand and the as the feed speed of the edges accelerate. During this occurrence, as paper is pulled to the direction of both edges, the trailing edge of the image may become distorted.

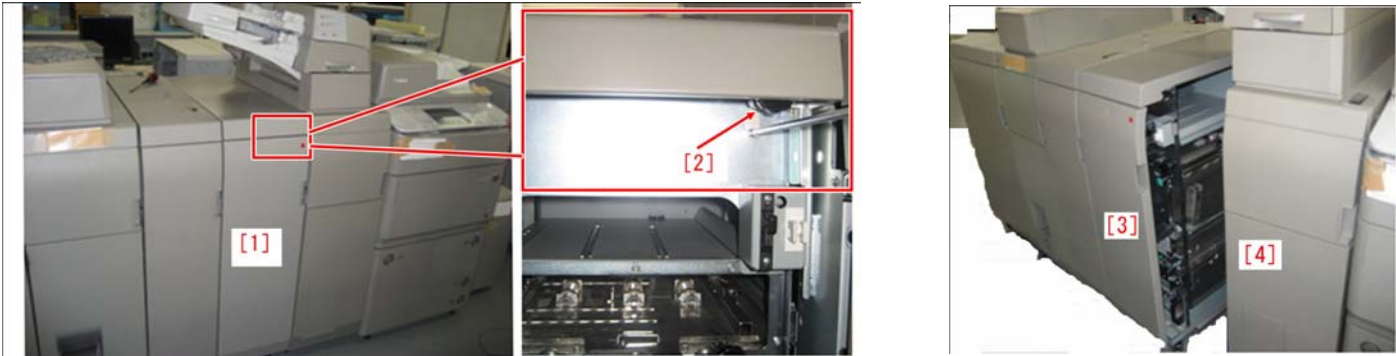
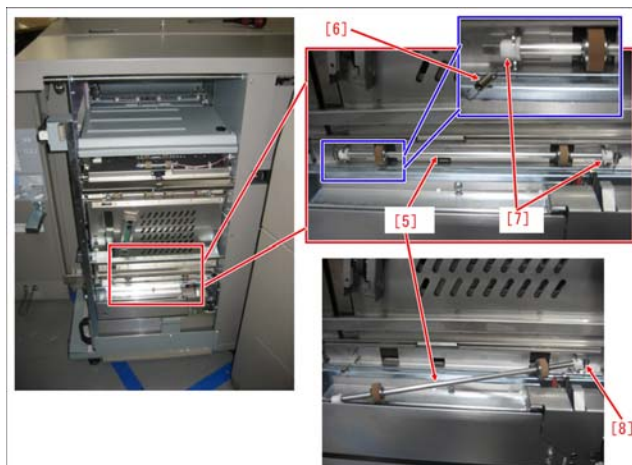
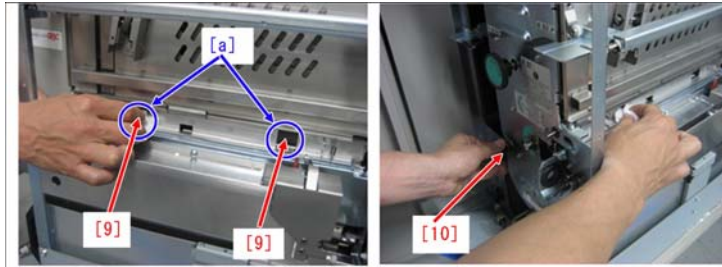
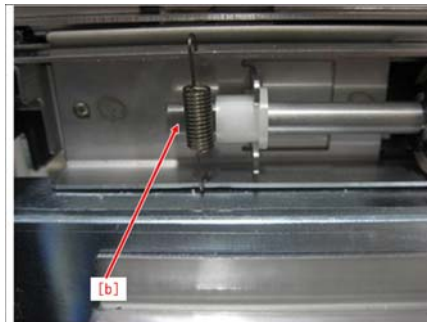
In the process of the Professional Puncher-C1 punching holes on paper, the puncher feeds the paper up to the punch area, and stops feeding once to punch holes. During the process, the drive roller was performing idle rotation on paper, and the same soil on the surface of the drive roller was found on the paper.

Follow the steps below to clean the soiled drive roller.

1) Open the front cover [1] of the Professional Puncher-C1 to release the connection lever [2], and separate the puncher [3] from the option [4] of the main body.

2) Remove the spring [6] at the front of the idle roller assembly [5] of the Professional Puncher-C1, and dismount the bushings [7] at the front and rear sides. Be sure to pull the idle roller assembly to the front while tilting it, and remove the spring [8] at the rear of the idle roller assembly.

3) Wipe out the soil on the drive roller [9] with alcohol through the 2 holes [a] of the guide plate. Rotate the knob [10] at the front side while cleaning it. The drive roller rotates by rotating the knob.

4) Mount the idle roller assembly.

6) Make a test copy with the puncher, and ensure that there is no roller marks on the paper.

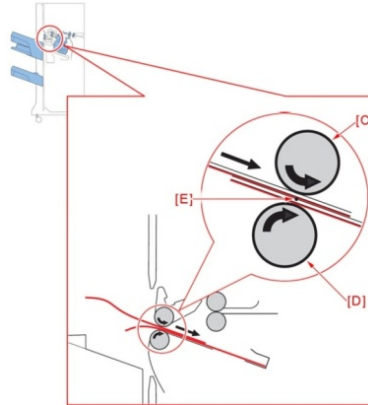
Soiling on the back of the sheet (Staple Finisher-D1/Booklet Finisher-D1)

When shift mode or staple mode is used, paper alignment is performed in the Process Tray Assembly of the Finisher. During paper alignment, the upper paper and the lower paper rub against each other at the portion [E] sandwiched between the Stack Delivery Upper Roller [C] and the Stack Delivery Lower Roller [D], and toner on the paper on the Stack Delivery Upper Roller side stick to the lower paper.

[Reference] This symptom occurs more frequently when paper having higher friction coefficient is used. It is assumed that when a mixture of sheets of coated paper and sheets of plain paper is used, toner on the plain paper stick to the coated paper, thereby soiling the back side of the paper.

Change the following setting of service mode according to the type of media with this symptom.

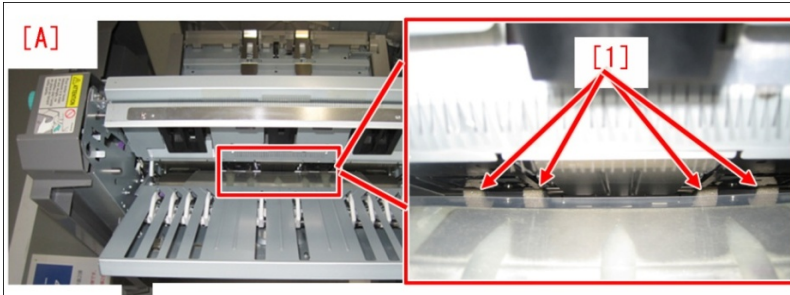
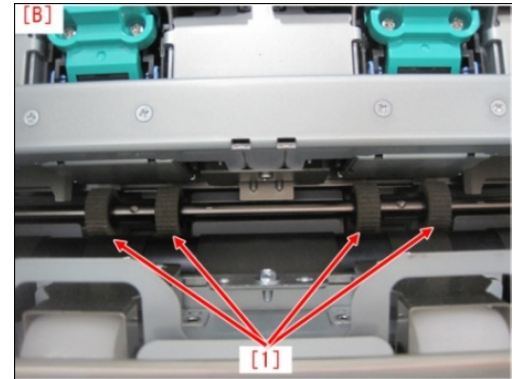
Illustration [A] is the Vertical Path Assembly viewed from above, illustration [B] is the view from the Saddle Stitch side.

When using the booklet function or folding function, paper is fed to the vertical path of the Saddle Stitch Assembly. As paper is sent to the Saddle tray, the Pull Rollers [1] (made of a sponge material) will touch the surface of the paper. If the pull rollers become contaminated with either paper dust or toner the contamination from the Pull Rollers will be transferred to the surface of the paper.

When the soiling occurs, replace the two estrangement rollers.

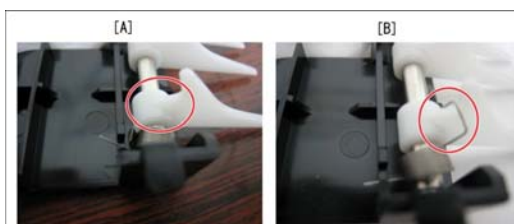
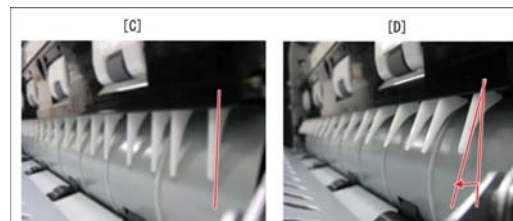
0115 Jam Code / Duplex Left Sensor Delay Jam

The Reverse Flapper does not operate if the Torsion Spring of the Reverse Flapper comes off.

[A] Indicates the Torsion Spring removed
[B] indicates a normal status.

[C] Reverse Flapper position with the
Torsion Spring" removed
[D] Normal position

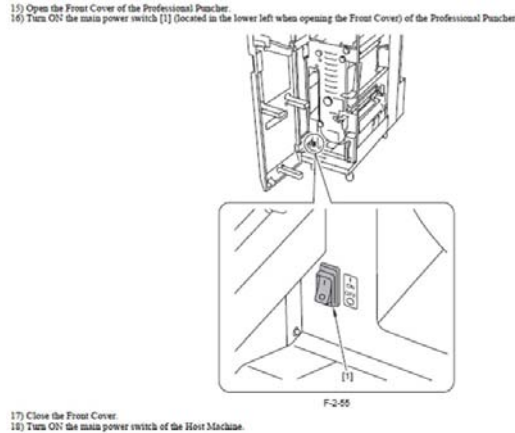
Upon installation the main power switch on the Pro Punch-C1 unit is in the "OFF" position. The power switch must be in the "ON" position prior to power cycling the main engine. The power switch on the Pro Punch-C1 should remain in the "ON" position thereafter.

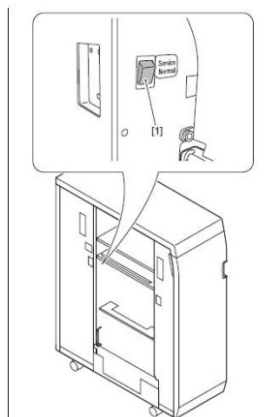
E503-0053: (Professional Puncher-C1)

E503-0053: Error code is a communication failure between the Integration Unit-B1 Professional Puncher-C1 (Professional Puncher Integration Unit-B1)

While servicing the Professional Puncher-C1 the service switch was inadvertently moved to the "Service" position. The following image shows the location of the service switch in the Professional Puncher-C1.

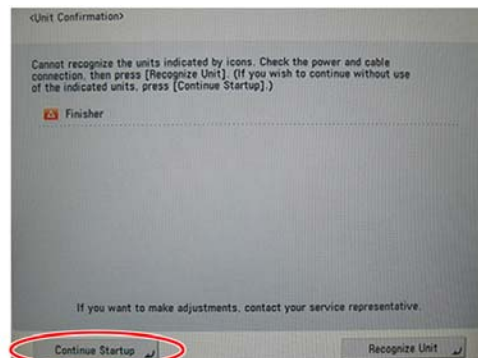
When pressing the "Continue Startup" button, the system starts up without the Finisher. Thereafter, when turning on the Finisher Main Power SW a 0CA4 jam code occurs.

0CA4: Page Complete time out jam

Problem occurs with the Finisher recognizes the DC Controller PCB due to the operations in the wrong order or "Continue Startup" operation after power-on. Even though the Finisher's Main Power SW is turned ON in this condition, no proper communication between the DC Controller PCB and Finisher is performed.

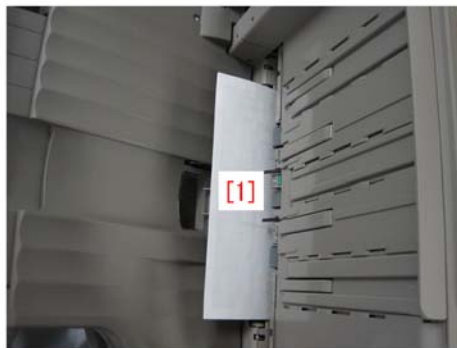
Symptom:**0CA4/1E00 Jam Code occurs with System Software earlier than version26.03 after removing sheets of paper from the processing tray (Staple/Booklet Finisher-D1)****Description:**

0CA4/1E00 Jam occurs upon removing sheets of paper [1] from the processing tray when the device had run out of paper or a jam has occurred.

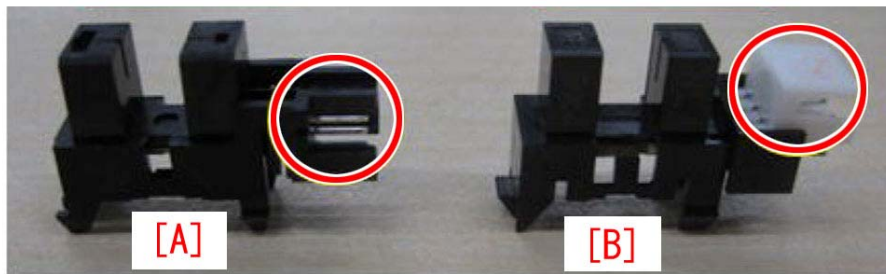
When paper is fed from the multi-feed pick-up assembly, the paper rubs against the metal plate of the multi-purpose tray, which results in being electrically charged. This charging caused faulty operation of the multi-purpose tray paper presence sensor to detect presence of paper on the multi-purpose tray.

5) Replace the Multi-Purpose Tray Paper Presence Sensor [1] with a new type part [B]:WG8-5783-000.
[Reference] Old type [A]: WG8-5848-000

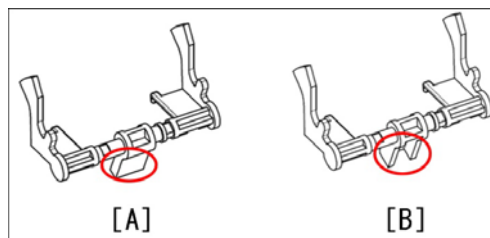
E583-8001/E583-8002 due to operation failure of the tray auxiliary guide (Booklet/Staple Fin-D1)

The position of the tray auxiliary guide is detected by the sub guide flag [1] and photo sensor [2]. The moving range of the sub guide flag becomes less than intended, which causes a failure to correctly detect ON/OFF by the photo sensor.

Prepare the two, new type sub guide flags (FC9-3081-010), and perform a replacement work by following the steps below. [A] is the old type and [B] is the new type.

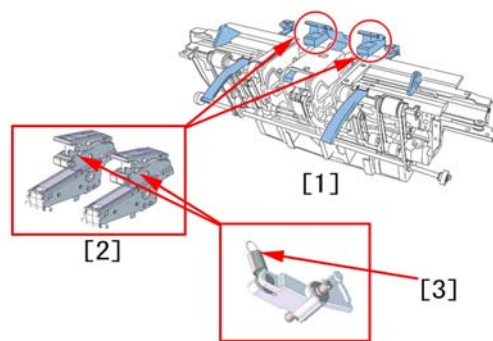
Paper delivery failure/stacking failure due to breakage in tension spring of finisher (Finisher-D1)

Booklet/Staple Finisher-D1 with a serial number earlier than the following serial numbers became unable to pick up the stack of paper reliably due to the breakage in the tension spring of the gripper arm assembly. This caused failure in paper delivery and stacking consecutively.

While the finisher is in operation, the gripper arm assembly [2] inside the dispose assembly [1] picks up the stack of delivered sheets and carries them. At this time, depending on the direction in which the tension spring [3] of the gripper arm assembly [2] is installed, the tension spring [3] may break due to its endurance. Accordingly, the stack of paper cannot be picked reliably.

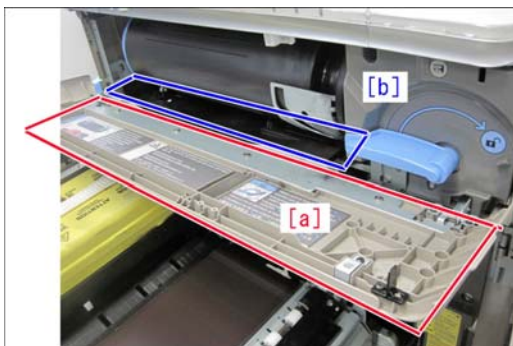
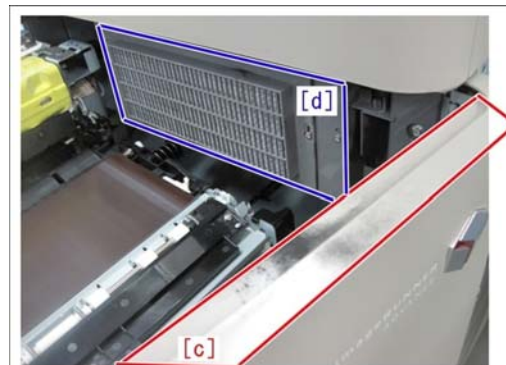
Open the upper front cover assembly. If the inner part[a] of the upper front cover assembly, the toner bottle mount area[b], and the lower front cover assembly[c] are soiled with toner, be sure to wipe off the toner.

Note: When cleaning the upper front cover assembly[a], the toner bottle mount area[b], and the lower front cover assembly[c]. Note: Be sure to check for contamination of the dustproof filter [d]. When it is contaminated, replace the dustproof filter (FC8-9564-000).

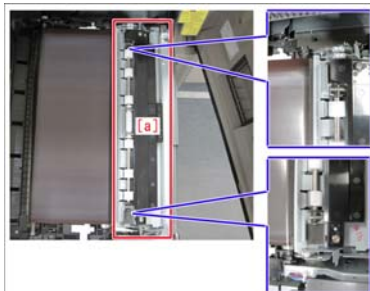
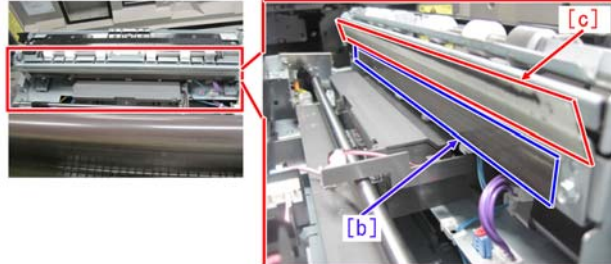
Check for toner soil on the upper part[a] of the registration assembly as well as on the magnetic sheet[b] and the plastic sheet[c] which face the surface of the ETB. If any soil is found, clean it.

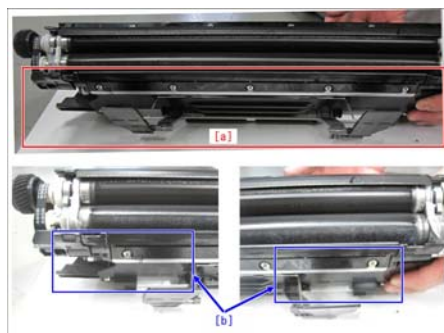
Developing Assembly

Wipe off the toner adhered to the lower part[a] of the developing assembly. Particularly, soil adhesion tends to appear in the edge portions[b] of the developing assembly.

Note: When cleaning the lower part of the developing assembly, be sure to clean the developing assembly guide mount.
